Equipment Inventory Sheet

#1 CARLISLE PIKE AND VAN PATTEN DRIVE

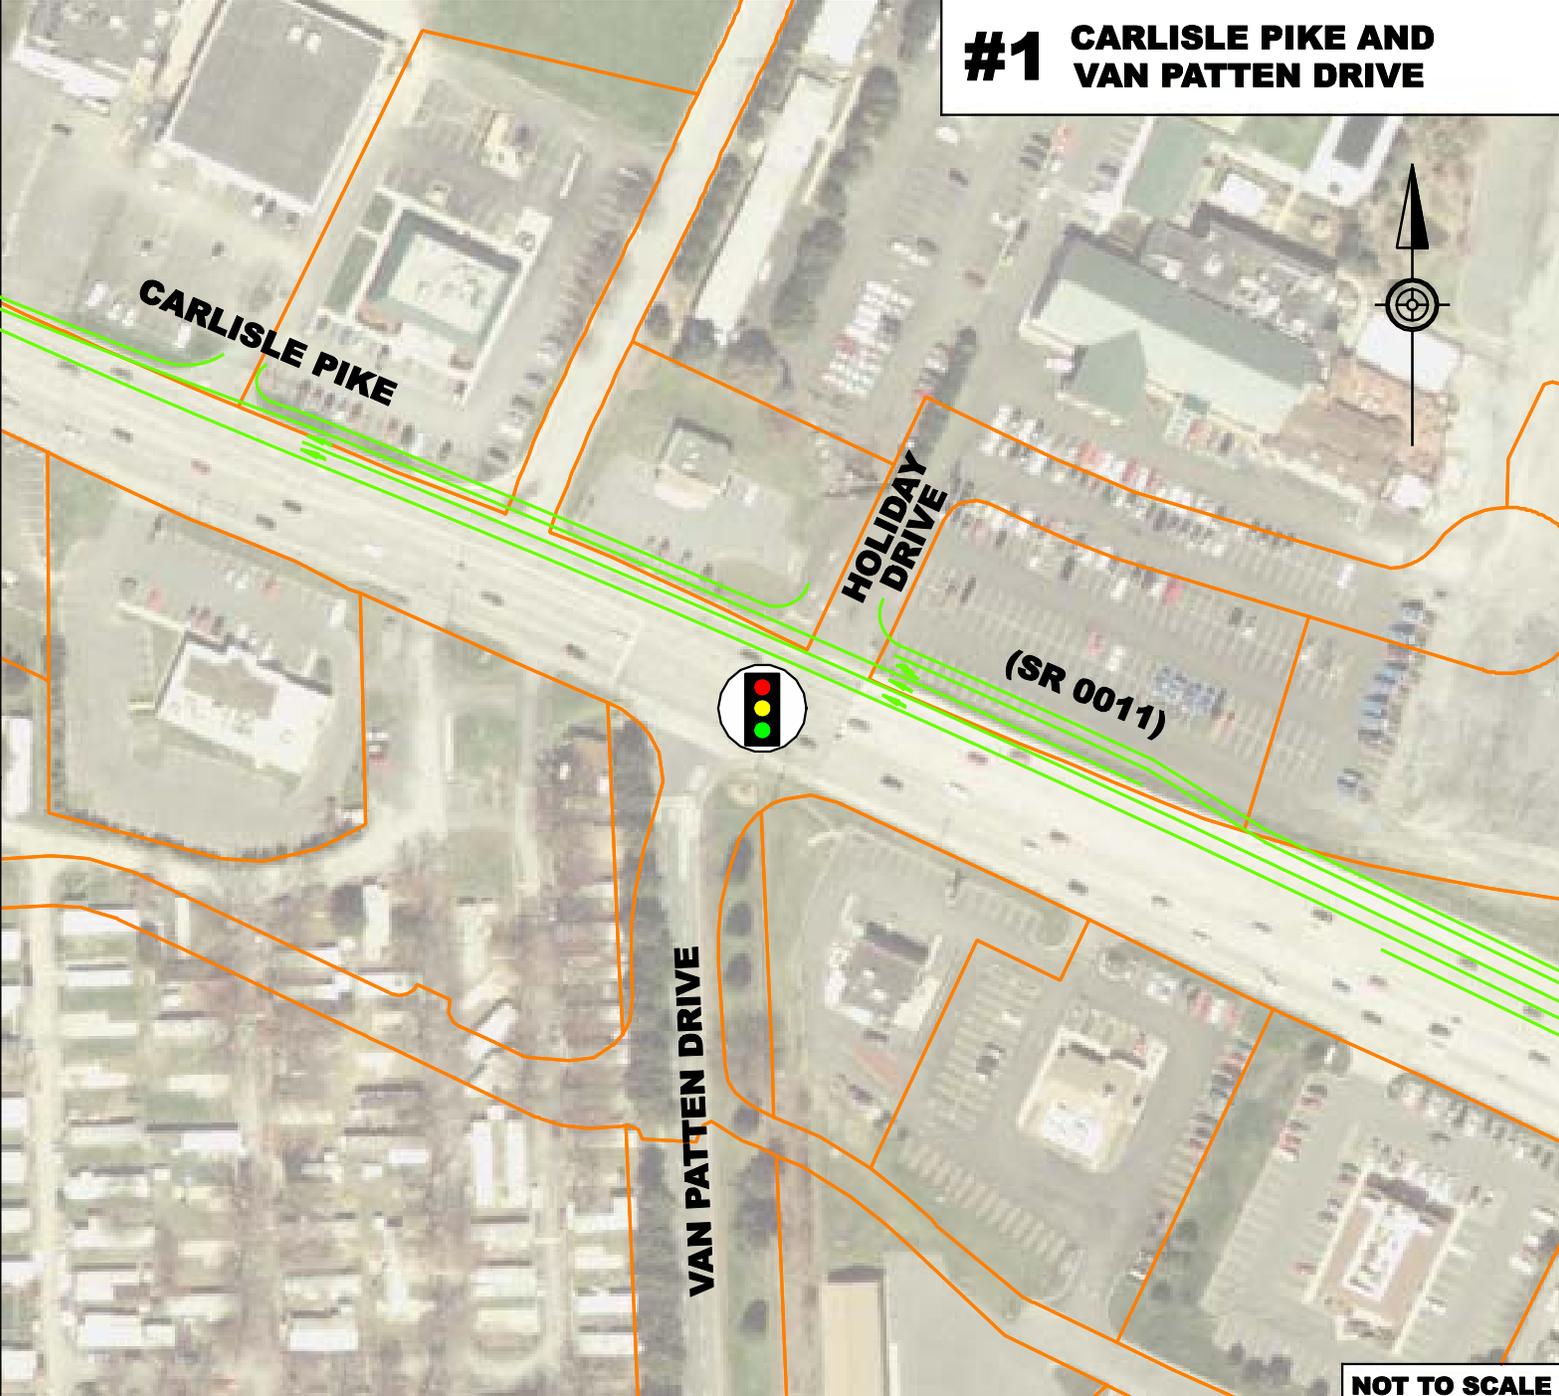
IMPROVEMENTS:	NO-BUILD	BUILD	ENVIRONMENTAL/ RIGHT-OF-WAY ISSUES:
	2007		
	B (B)		
	2020		
SHORT TERM:	B (C)	B (B)	No environmental issues of note. Right-of-way will be required from hotel and businesses along north side of US 11
<ul style="list-style-type: none"> • Add third through lane on westbound Carlisle Pike • Add 200' right-turn lane on westbound Carlisle Pike • Improve Signal Timings and Coordination • Update pedestrian phase lengths to conform with MUTCD requirements • Modify/install crosswalks and curb-cut ramps to conform with ADA requirements 	2030		
LONG TERM:	B (C)	B (B)	
<ul style="list-style-type: none"> • Improve Signal Timings and Coordination

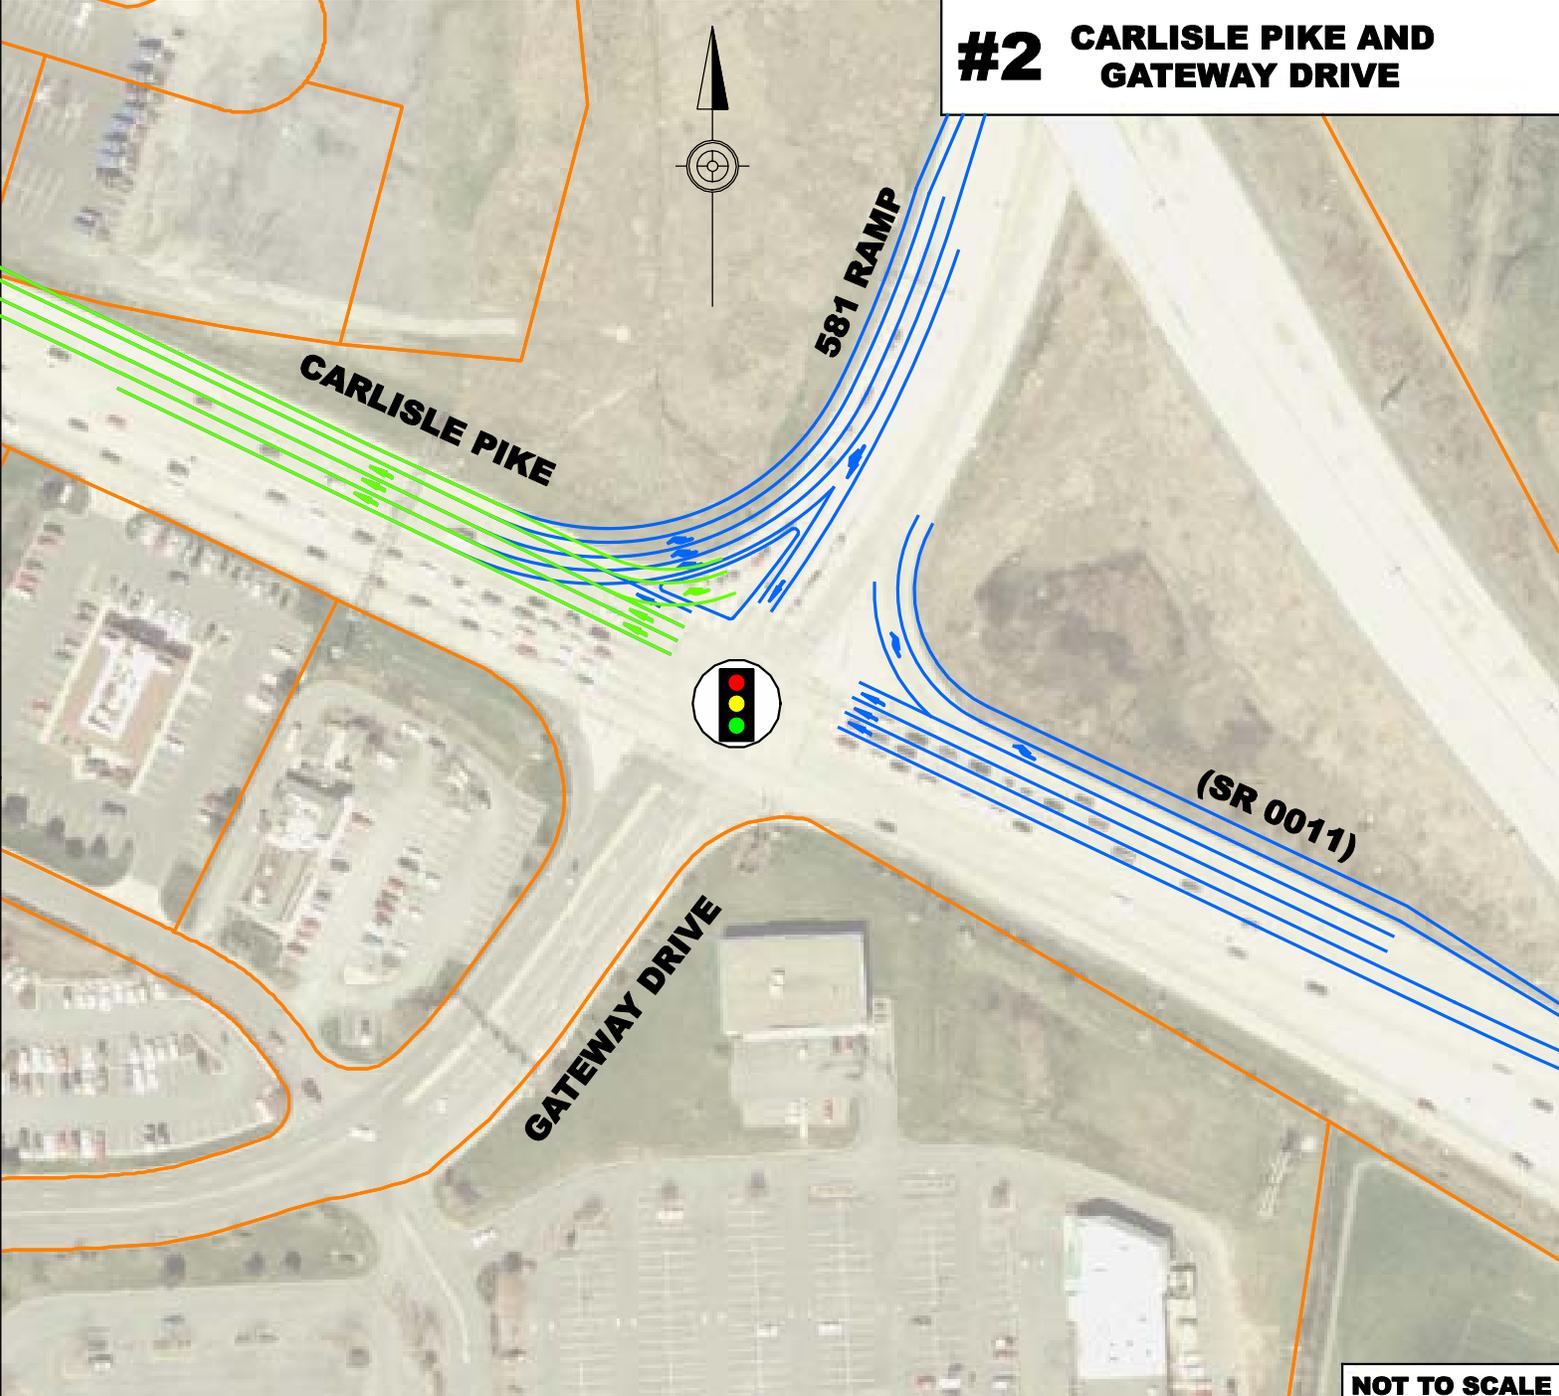
#2 CARLISLE PIKE AND GATEWAY DRIVE

IMPROVEMENTS: IMMEDIATE: SHORT TERM: <ul style="list-style-type: none"> • Connect southbound right-turn lane from PA-581 Ramps to third westbound through lane on Carlisle Pike • Improve Signal Timings and Coordination • Update pedestrian phase lengths to conform with MUTCD requirements • Modify/install crosswalks and curb-cut ramps to conform with ADA requirements LONG TERM: <ul style="list-style-type: none"> • Add two additional channelized right-turn lanes on southbound PA-581 Ramps • Add a third through lane on westbound Carlisle Pike • Improve Signal Timings and Coordination 	NO-BUILD	BUILD	ENVIRONMENTAL/ RIGHT-OF-WAY ISSUES: No significant environmental issues to note Most work will be completed within existing ramp areas and within PennDOT right-of-way
	2007		
	D(F)	X	
	2020		
	D(F)	B(B)	
	2030		
	E(F)	B(B)

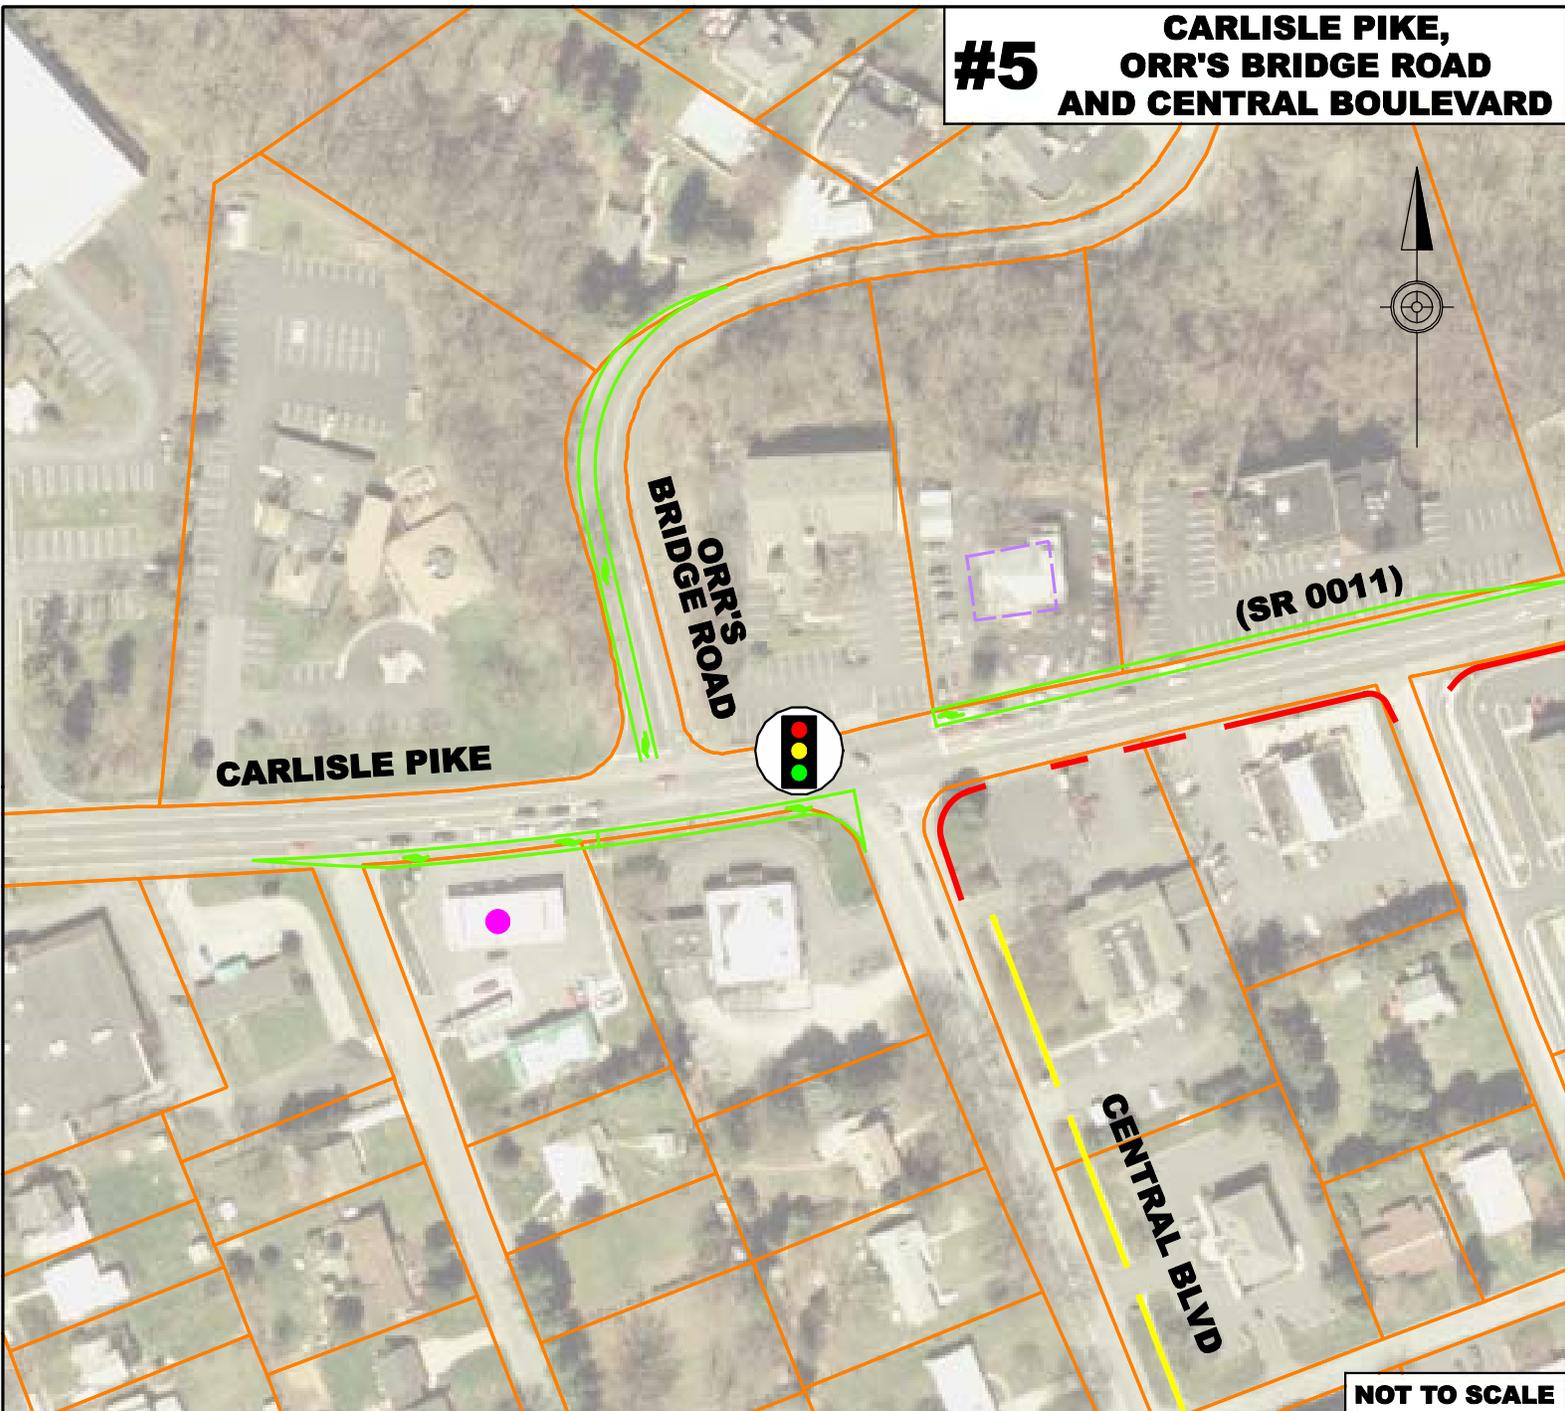
**CARLISLE PIKE,
ORR'S BRIDGE ROAD
AND CENTRAL BOULEVARD**

ENVIRONMENTAL/ RIGHT-OF-WAY ISSUES:
Potential hazardous waste- Hess Gas
Potential historic resource- Andrew Moore House
Right-of-way would be required for the 2020 Improvements. Right-of-way along the north side of US 11 would require commercial driveway adjustments. Right-of-way on the south side of US 11 would require commercial and environmental interaction.

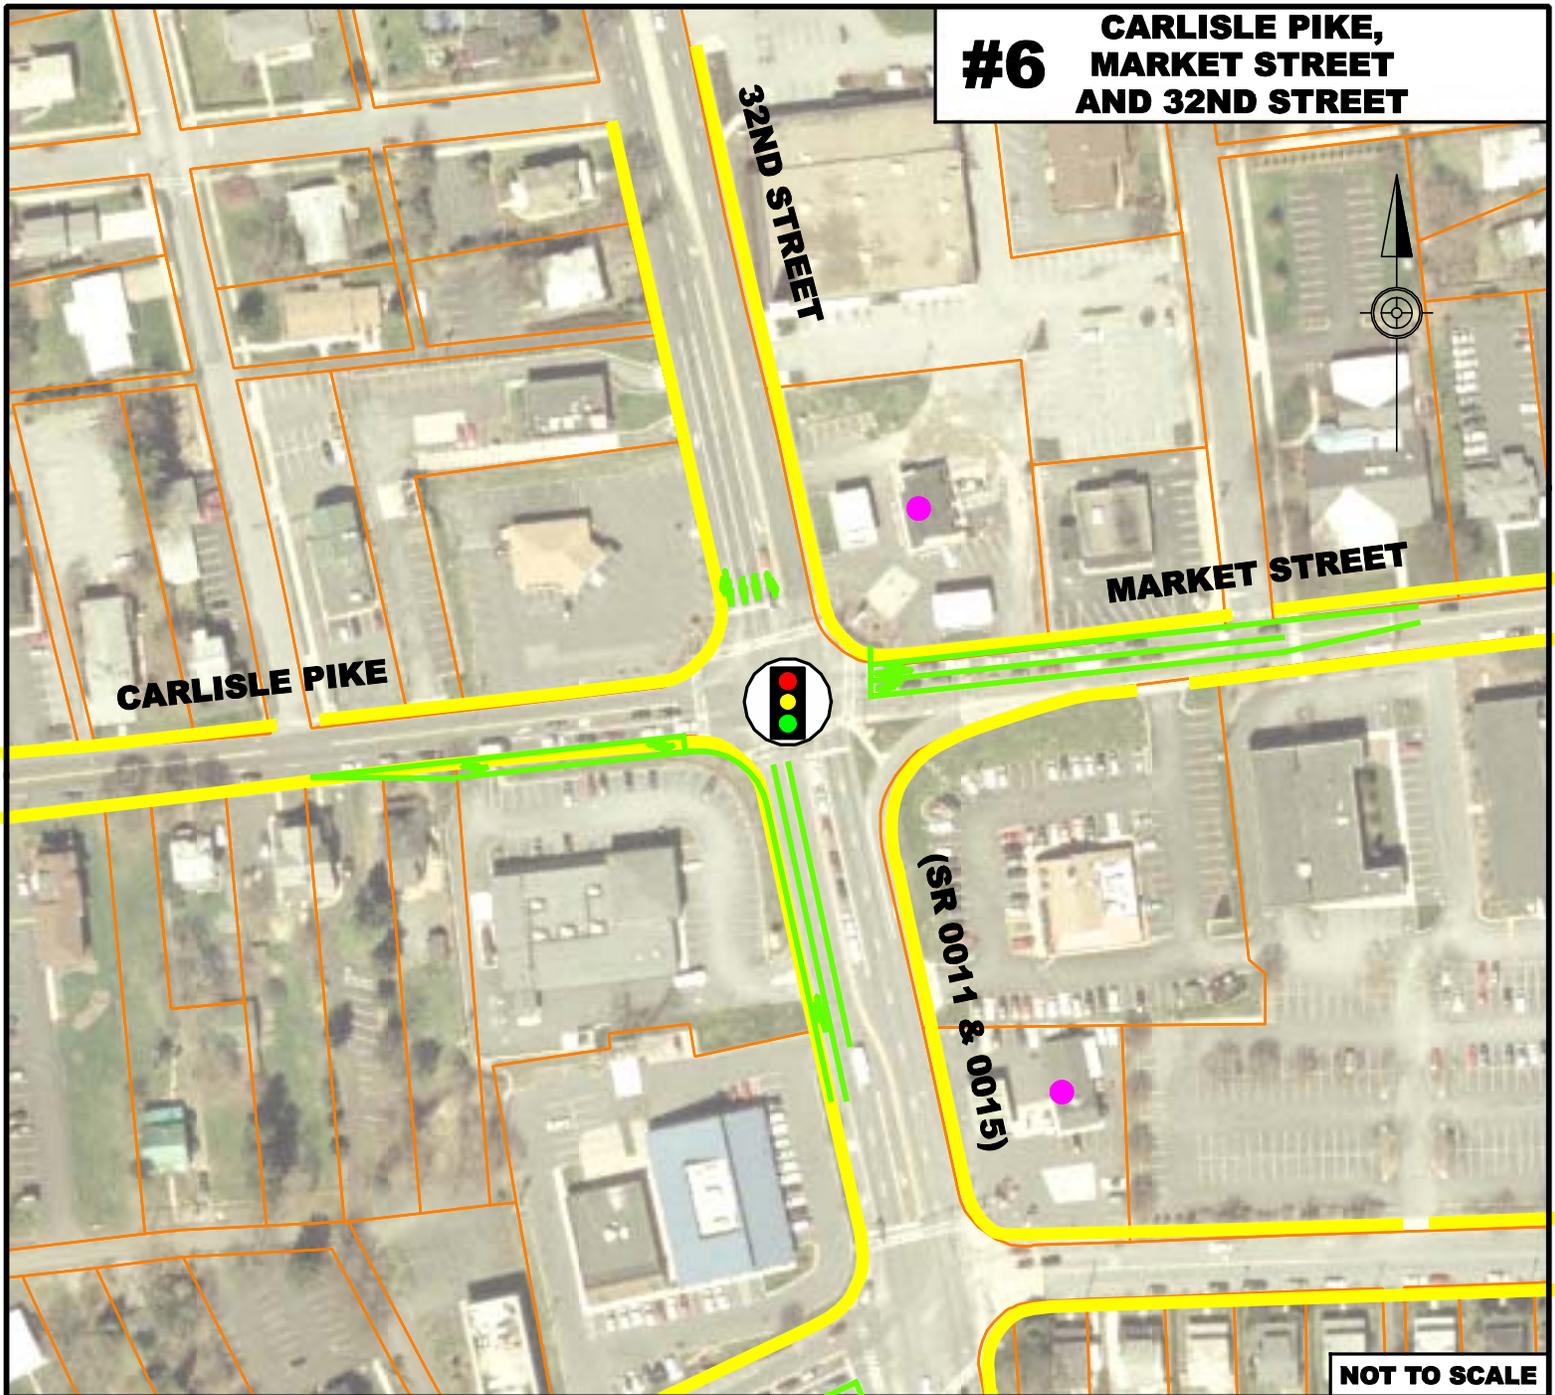
#6 CARLISLE PIKE, MARKET STREET AND 32ND STREET

A Plus Sunoco Gas
Right-of-way would be required from a commercial property and a commercial driveway adjustment on the south side of the Carlisle Pike

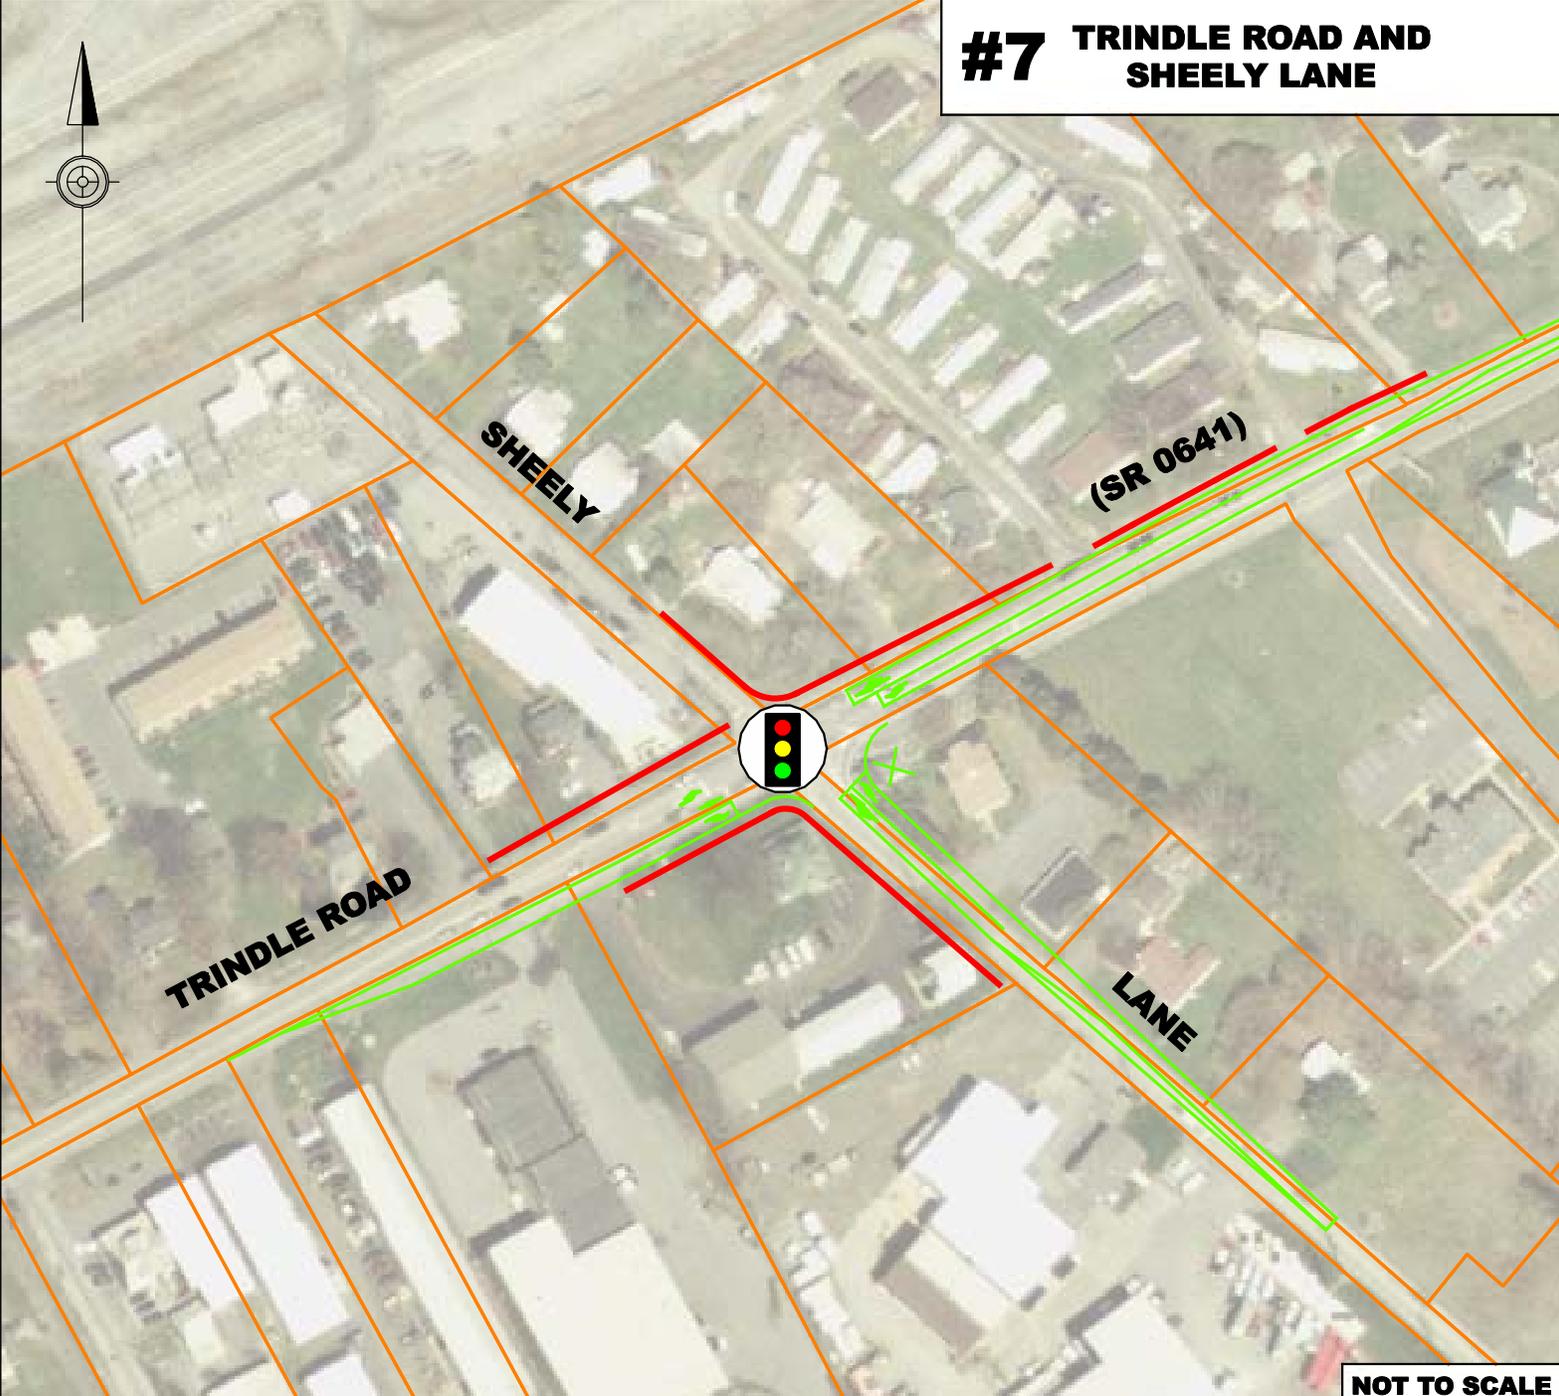
#7 TRINDLE ROAD AND SHEELY LANE

IMPROVEMENTS: IMMEDIATE: SHORT TERM: <ul style="list-style-type: none"> • Add a 150' shared through/left-turn lane on northbound Sheely Lane • Add a 265' exclusive right-turn lane on eastbound Trindle Road • Lengthen the left-turn lane on westbound Trindle Road to approx. 400' • Improve Signal Timings and Coordination • Update pedestrian phase lengths to conform with MUTCD requirements • Modify/Install crosswalks and curb-cut ramps to conform with ADA requirements LONG TERM: <ul style="list-style-type: none"> • Improve Signal Timings and Coordination 	NO-BUILD	BUILD	ENVIRONMENTAL/ RIGHT-OF-WAY ISSUES: Acquire Property on Southeast Quadrant Driveway modifications and minor right-of-way will be required on the north side of Trindle Road Driveway modifications and some commercial property will be required on the southwest quadrant
	2007		
	C(D)	X	
	2020		
	F(E)	C(B)	
2030			
	F(F)	C(C)

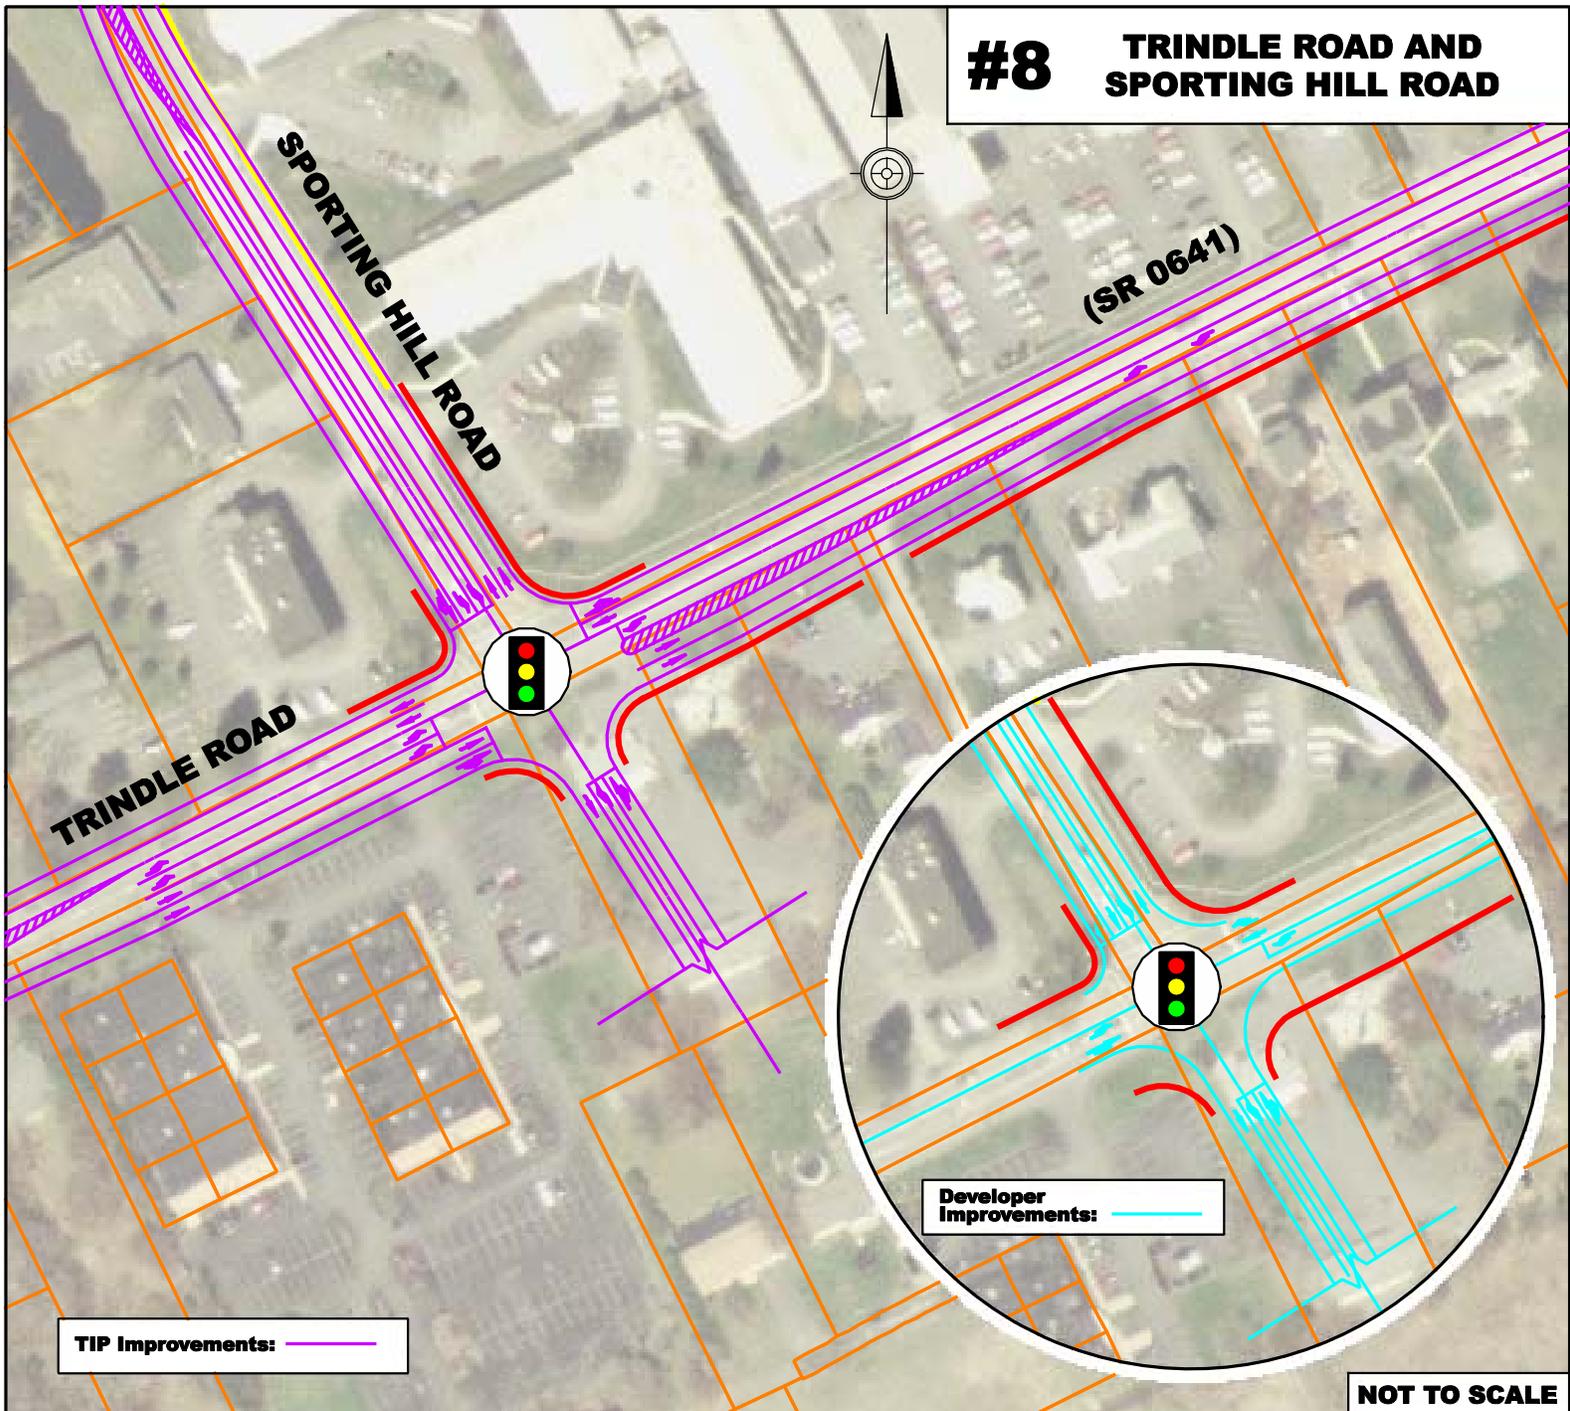
#8 TRINDLE ROAD AND SPORTING HILL ROAD

No environmental issues of note
Significant right-of-way will be required for both the TIP improvements and the developer improvements.

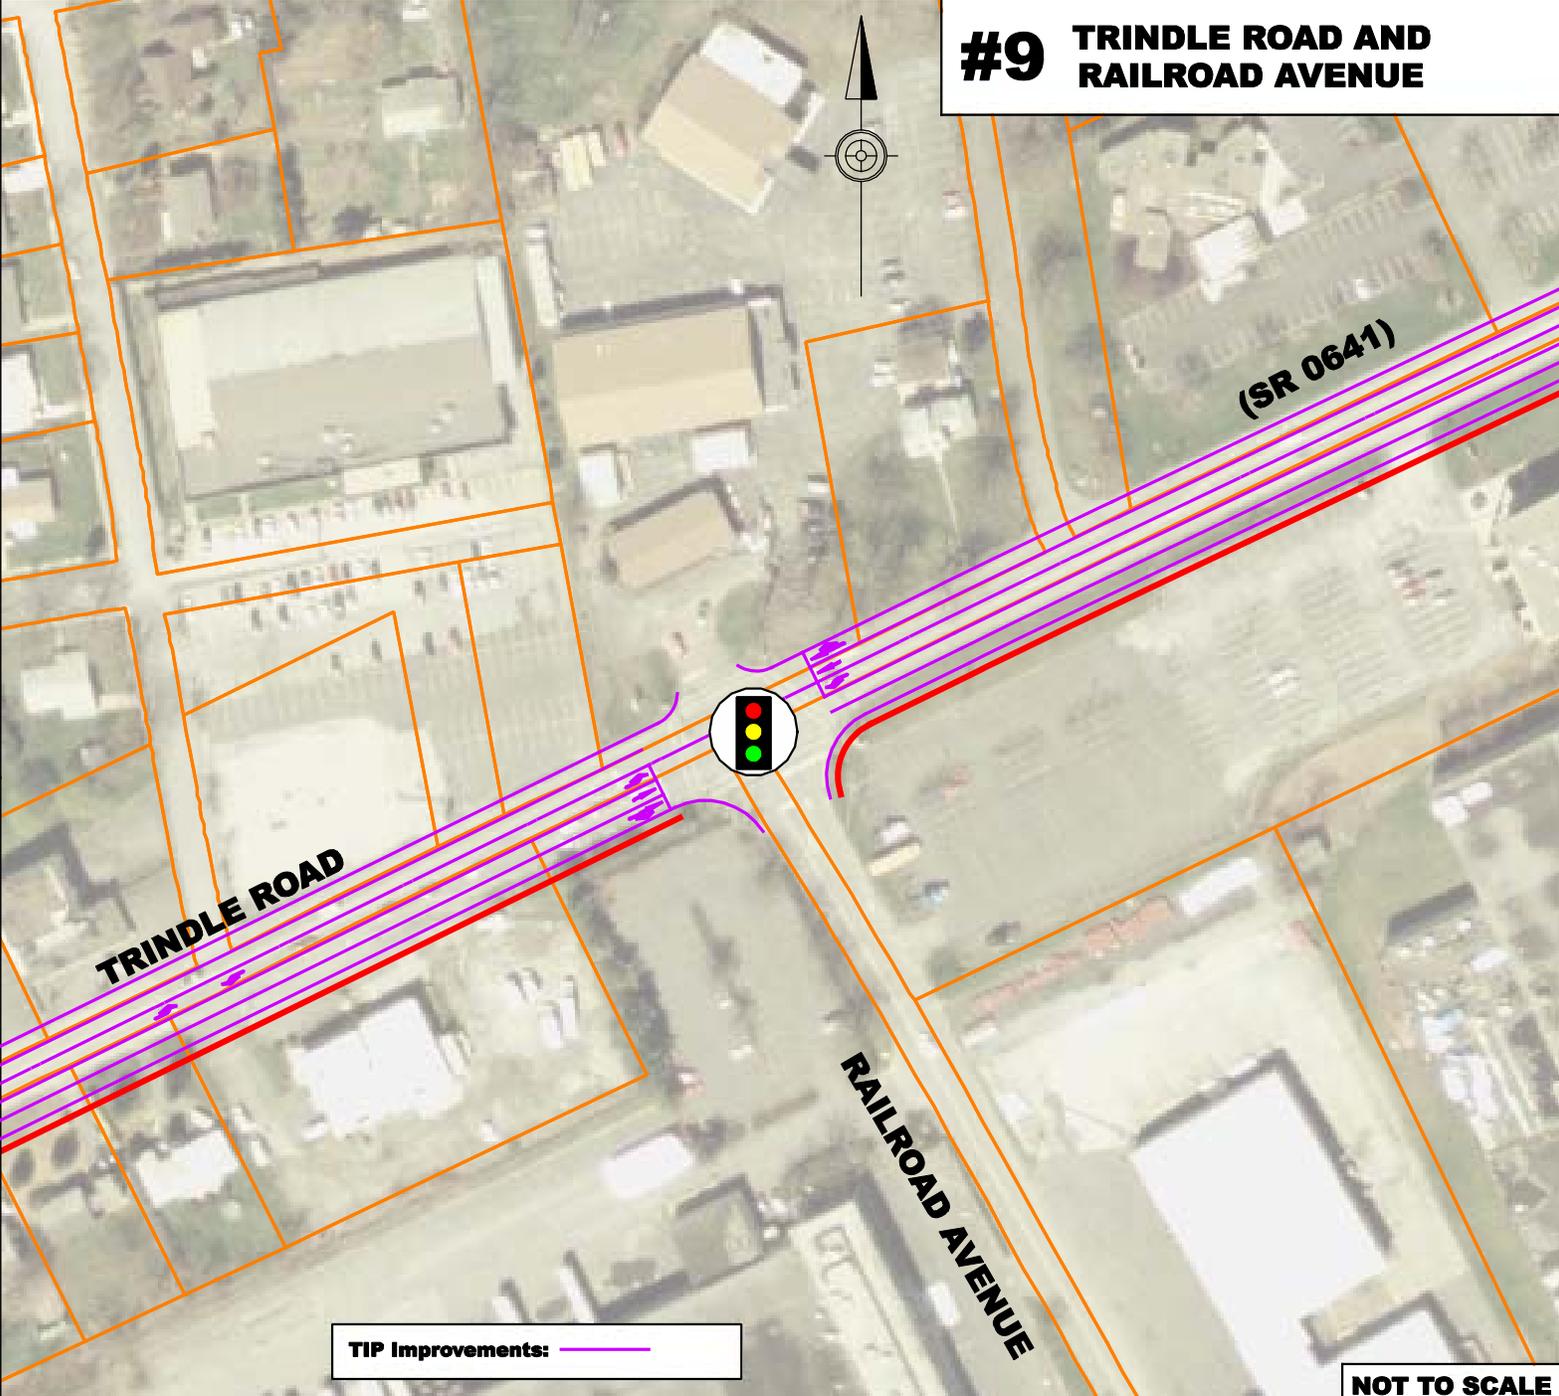
#9 TRINDLE ROAD AND RAILROAD AVENUE

IMPROVEMENTS:	NO-BUILD	BUILD	ENVIRONMENTAL/ RIGHT-OF-WAY ISSUES:
	2007		
	B(B)		
	2020		
SHORT TERM:	C(B)	C(B)	No environmental issues of note TIP widening will require significant right-of-way and driveway modifications
<ul style="list-style-type: none"> • Improve Signal Timings and Coordination • Update pedestrian phase lengths to conform with MUTCD requirements • Modify/Install crosswalks and curb-cut ramps to conform with ADA requirements 			
2030			
LONG TERM:	C(B)	C(C)	
<ul style="list-style-type: none"> • TIP Improvements: Widen Trindle Road approaches for 5-Lane cross-section • Improve Signal Timings and Coordination

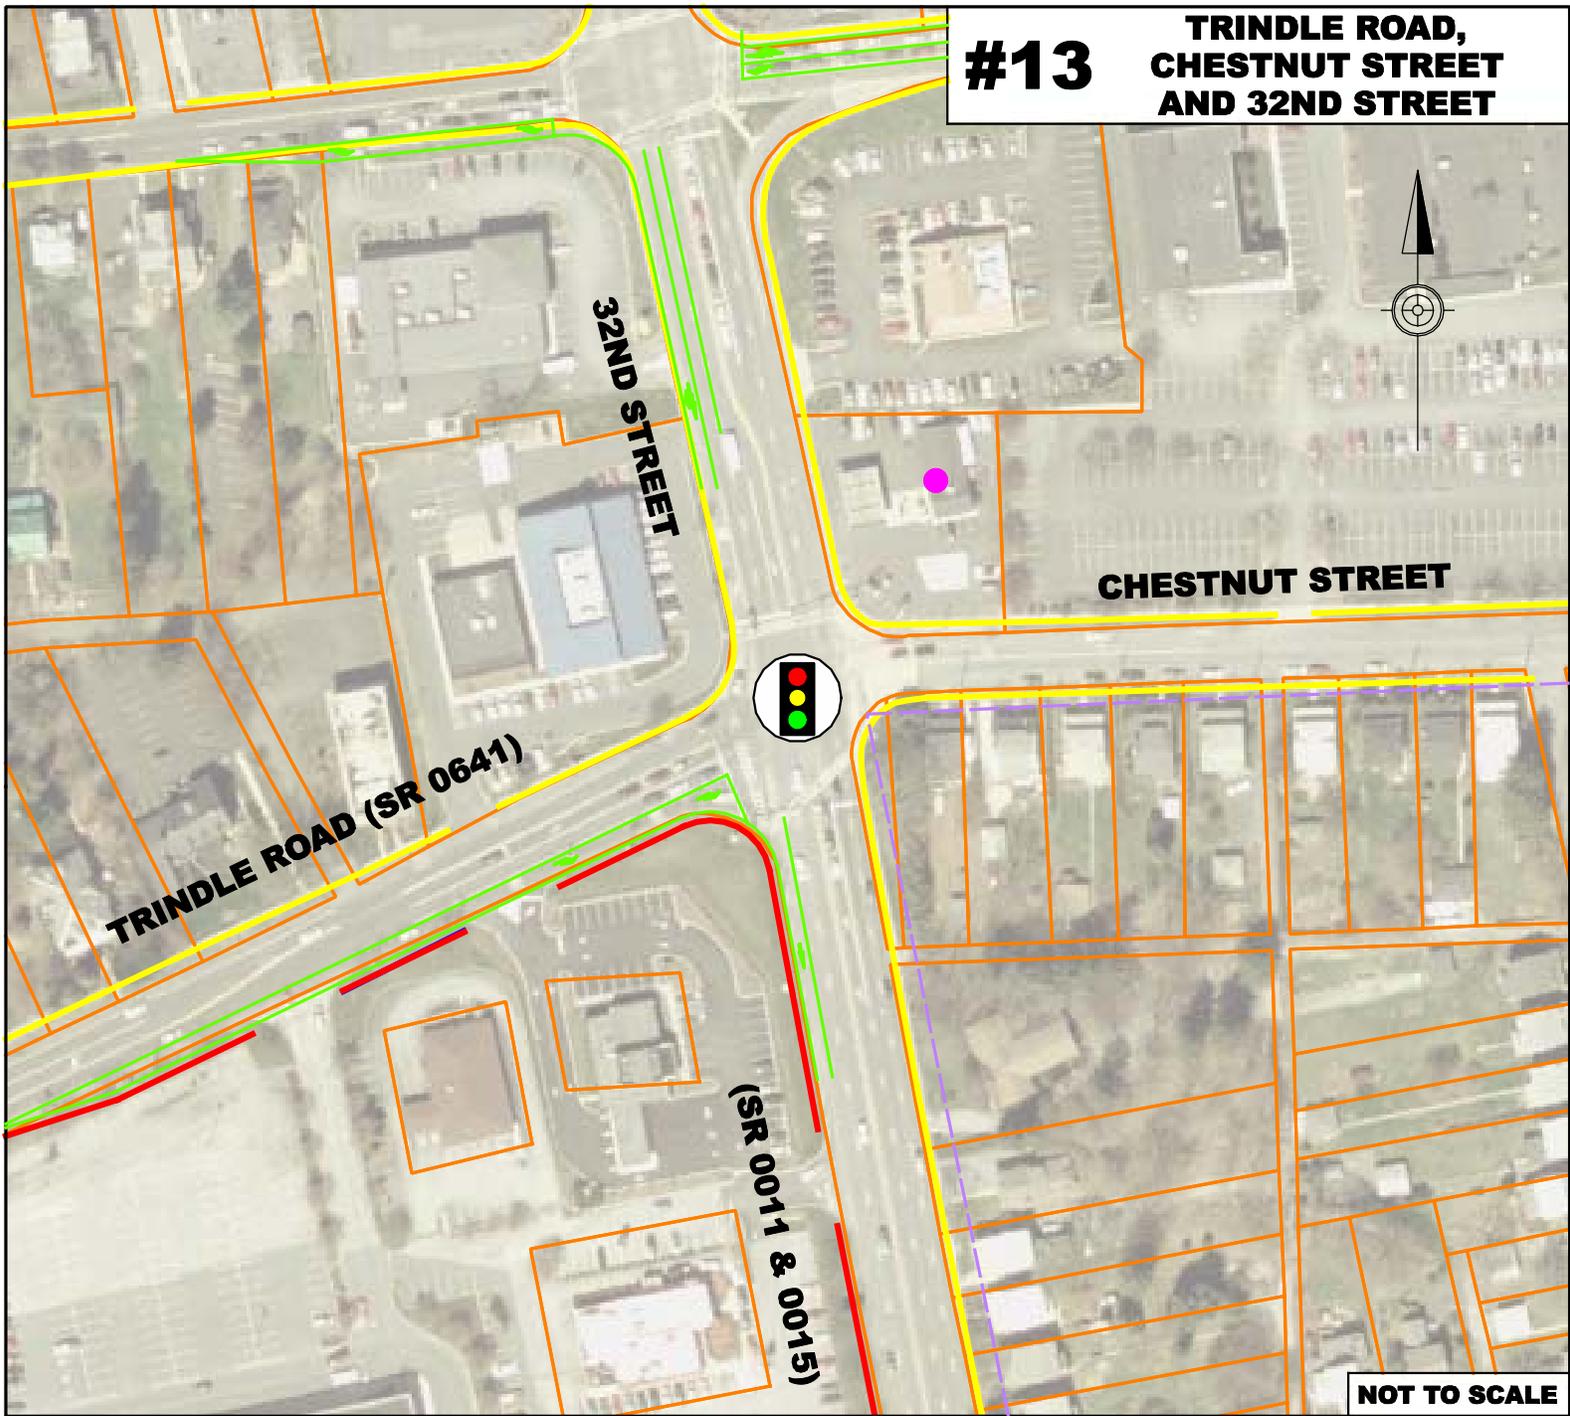
TRINDLE ROAD, CHESTNUT STREET AND 32ND STREET

IMPROVEMENTS:	NO-BUILD	BUILD	ENVIRONMENTAL/ RIGHT-OF-WAY ISSUES:
	2007		
IMMEDIATE:	F(F)	X	Potential hazardous waste - Giant Gas Potential historic resource - Residential Development Minor right-of-way impacts and driveway modifications to the properties on the southwest quadrant of the intersection
SHORT TERM:	2020		
<ul style="list-style-type: none"> Create a third through lane on southbound 32nd Street Widen to south of Trindle/Chestnut to continue third through lane to PA-581 interchange Lengthen the right-turn lane on eastbound Trindle Road to 500' Improve Signal Timings and Coordination 32ND STREET PEDESTRIAN OPTION A: <ul style="list-style-type: none"> Maintain exclusive pedestrian phases 32ND STREET PEDESTRIAN OPTION B: <ul style="list-style-type: none"> Replace exclusive pedestrian phases with semi-exclusive pedestrian phasing Modify crosswalk configurations 	F(F)	F(F)	
LONG TERM:	2030

<ul style="list-style-type: none"> Improve Signal Timings and Coordination 	F(F)	F(F)

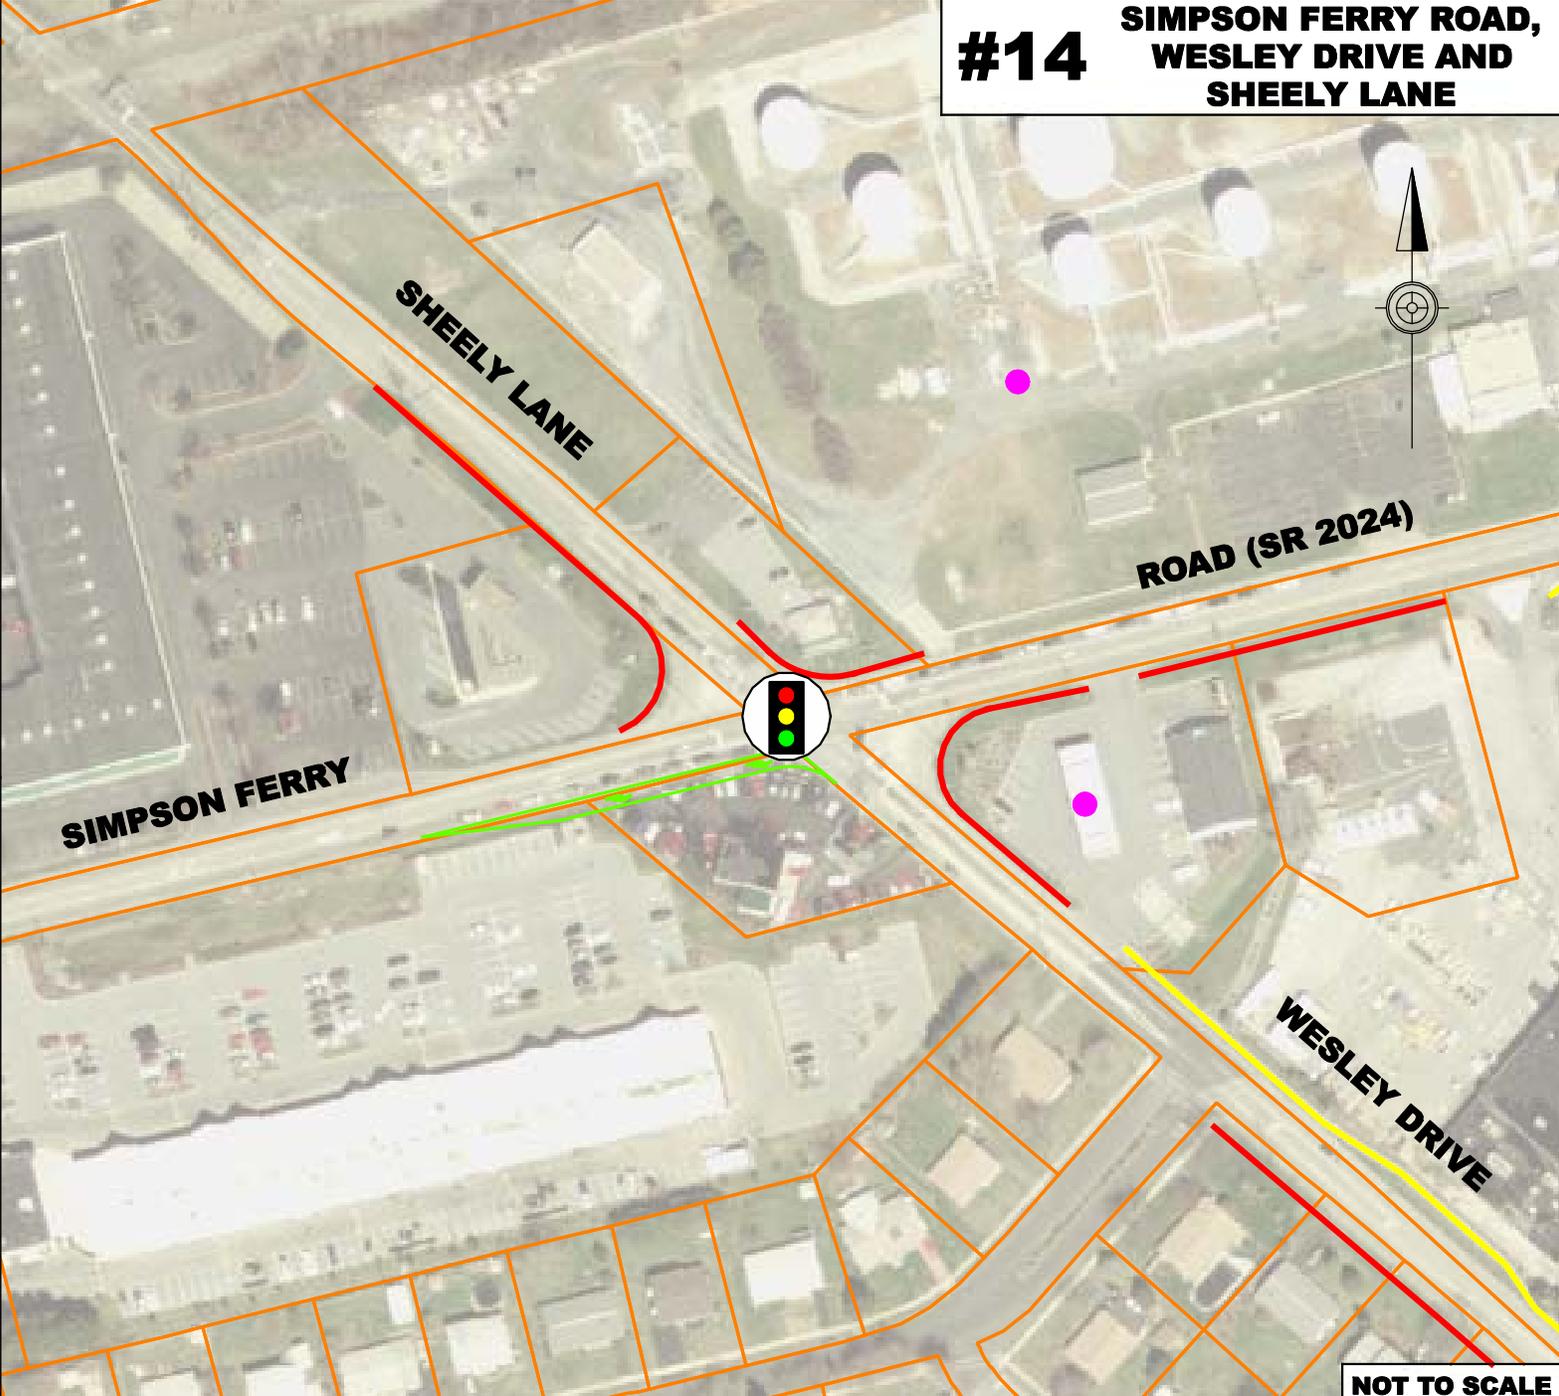
#14 SIMPSON FERRY ROAD, WESLEY DRIVE AND SHEELY LANE

IMPROVEMENTS:	NO-BUILD	BUILD	ENVIRONMENTAL/ RIGHT-OF-WAY ISSUES:
	2007		
	D(D)		
	2020		
SHORT TERM:	E(E)	C(D)	<p>Potential hazardous waste - Turkey Hill Gas & Sun Company Bulk Storage</p> <p>Right-of-way will be required from property on southwest quadrant of the intersection. Parking and driveway adjustments may be problematic</p>
<ul style="list-style-type: none"> Add 150' right-turn lane on eastbound Simpson Ferry Road Improve Signal Timings and Coordination Update pedestrian phase lengths to conform with MUTCD requirements Modify/install crosswalks and curb-cut ramps to conform with ADA requirements 	2030		
LONG TERM:	E(E)	D(E)	
<ul style="list-style-type: none"> Improve Signal Timings and Coordination
