Equipment Inventory Sheet

#1 CARLISLE PIKE AND VAN PATTEN DRIVE

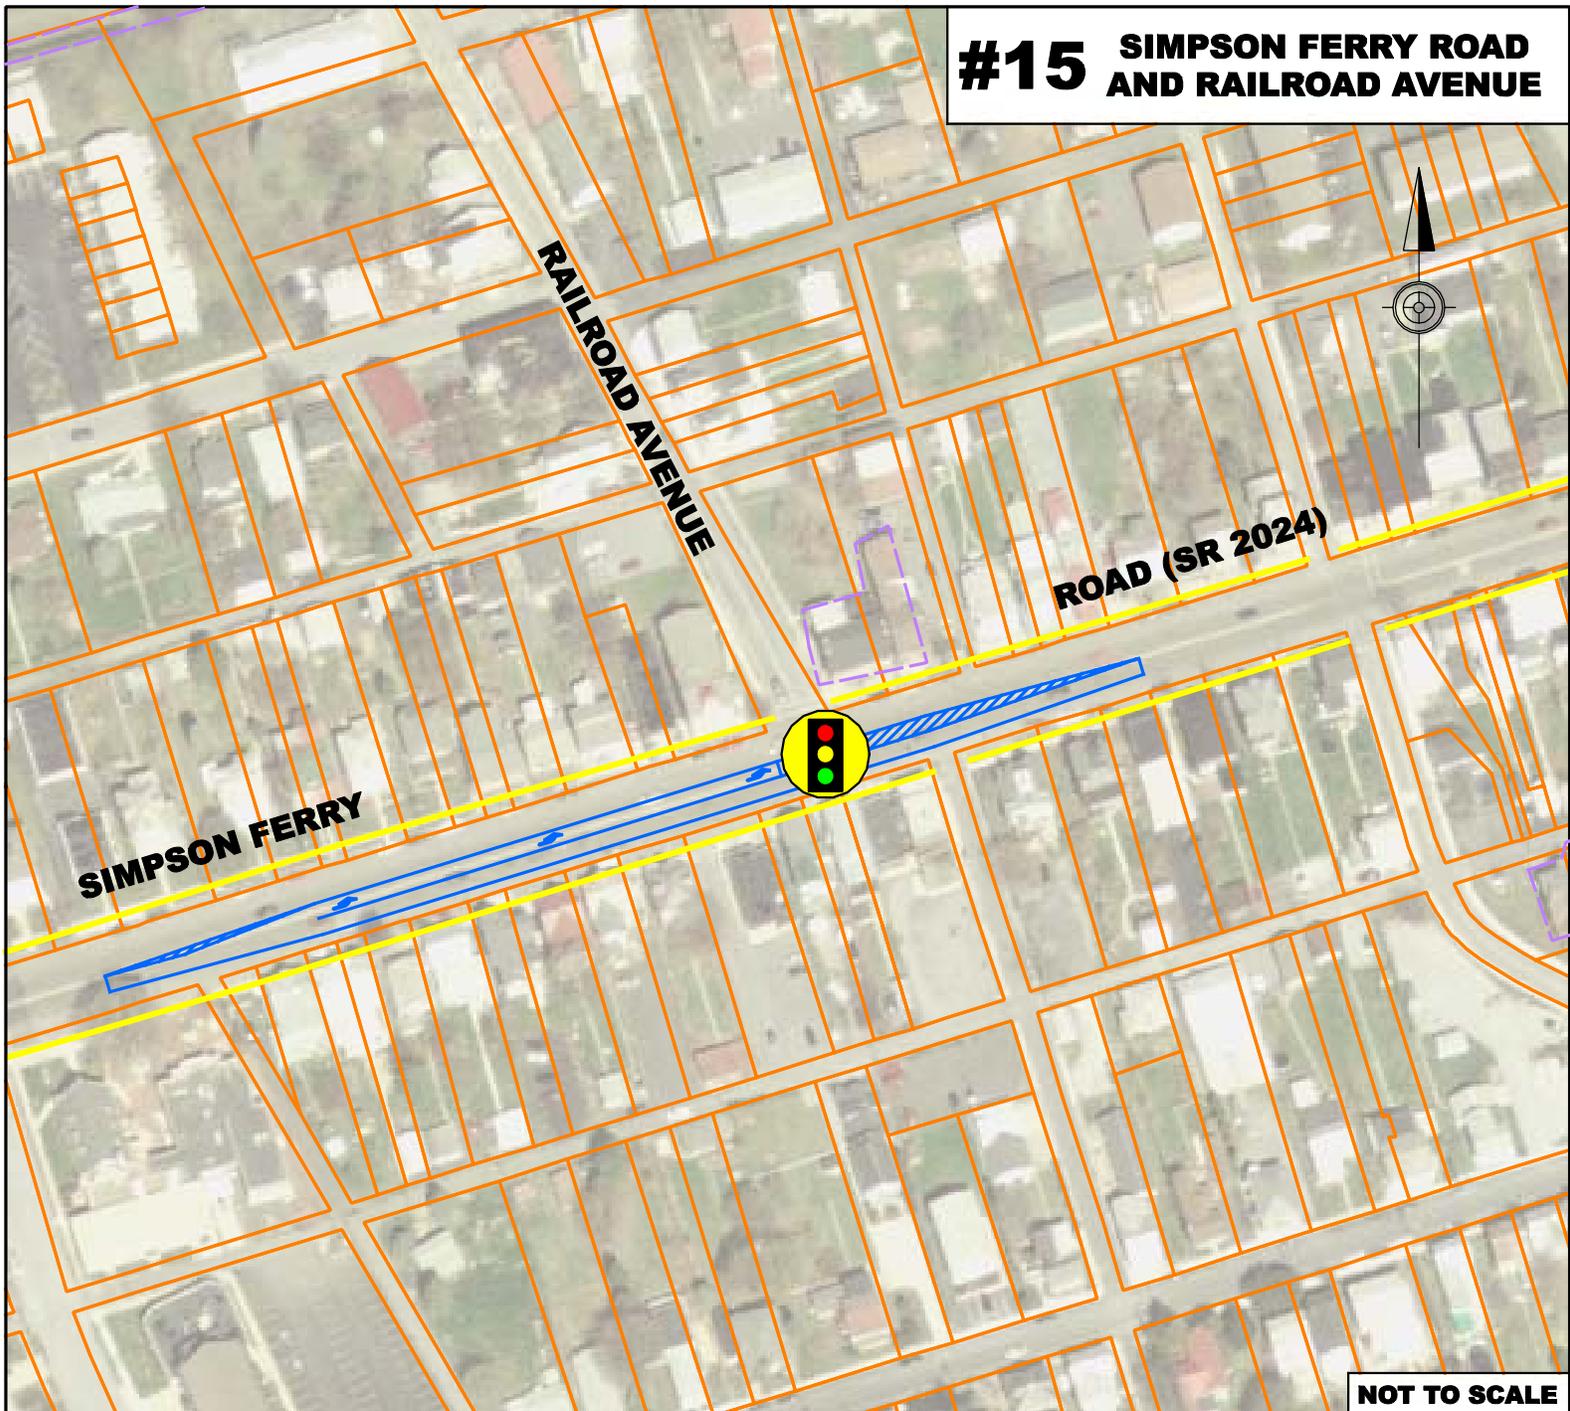
#15 SIMPSON FERRY ROAD AND RAILROAD AVENUE

2030 widening can most likely be completed within existing right-of-way. Some driveway adjustments may be required.

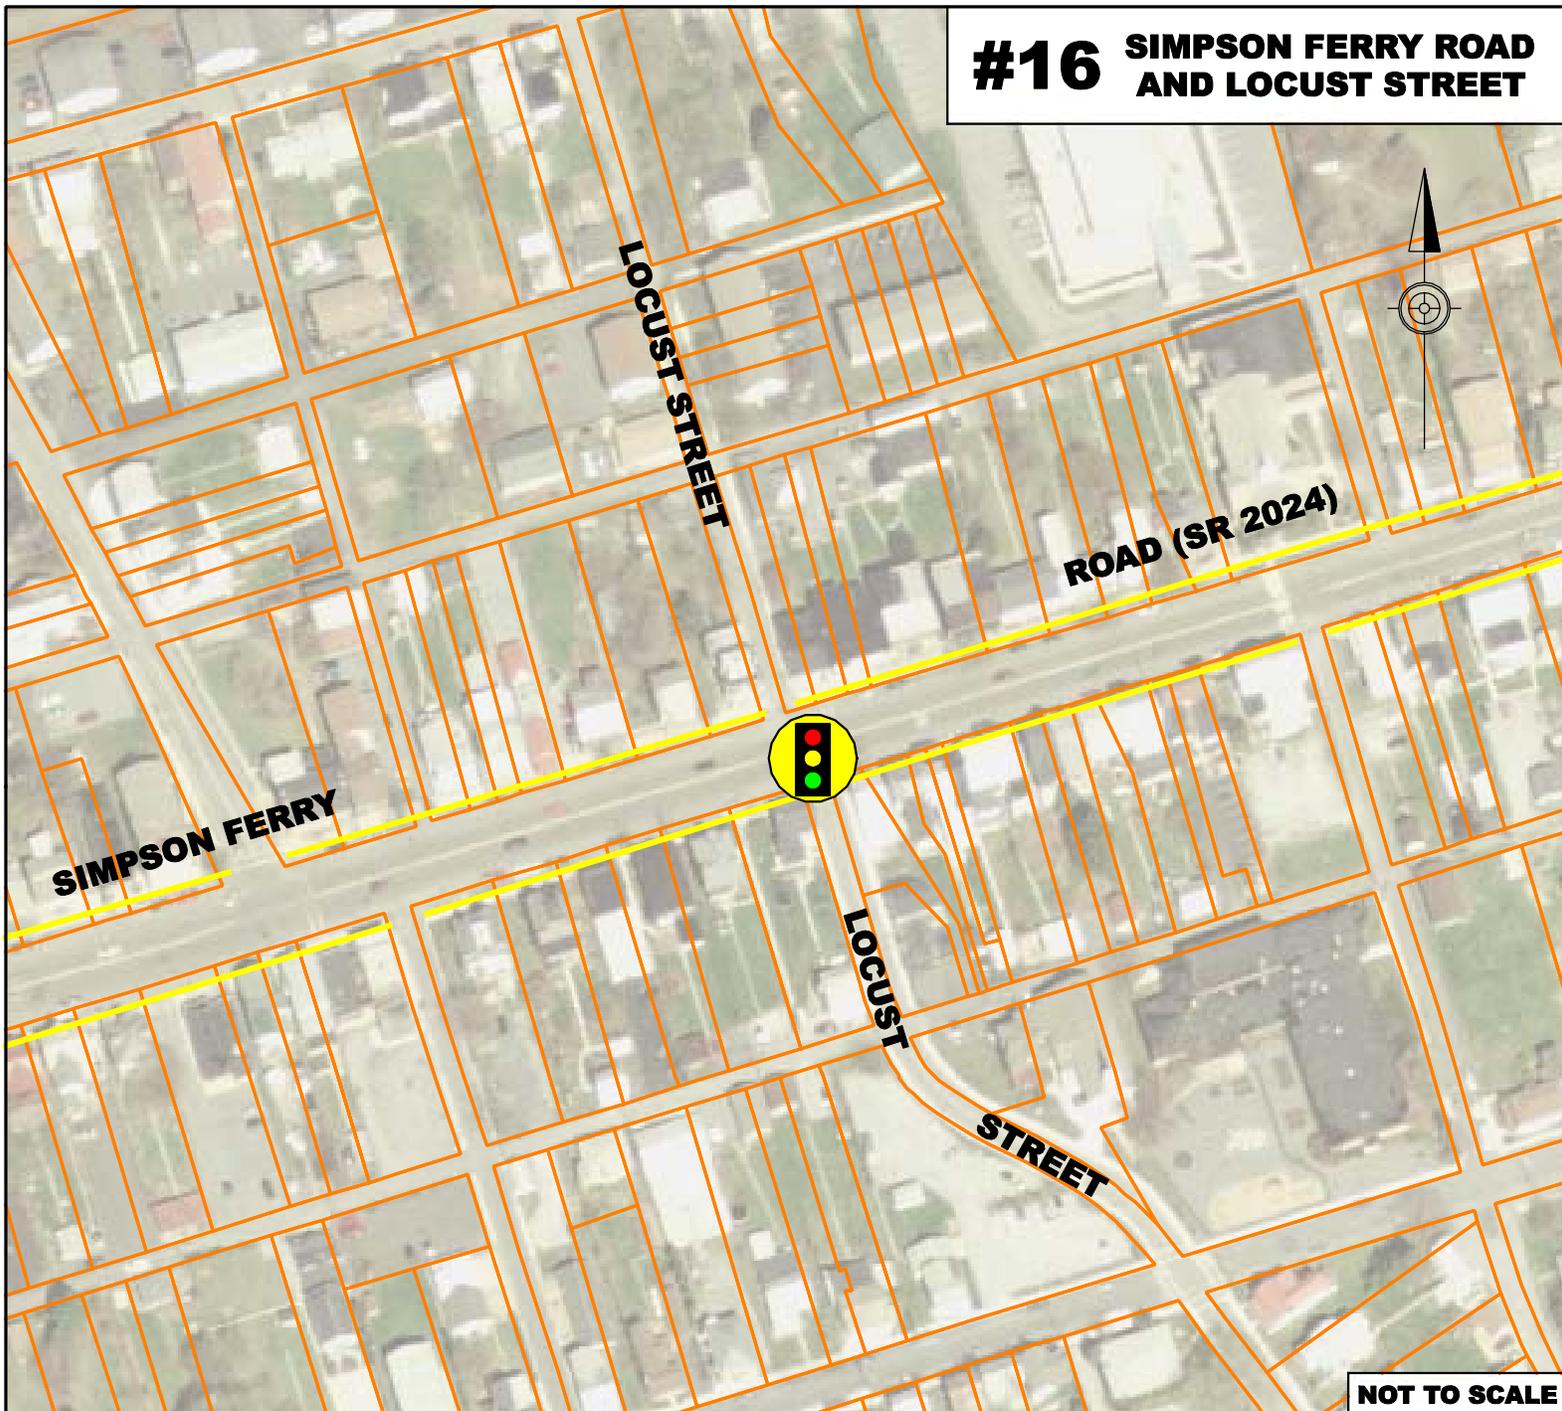
#16 SIMPSON FERRY ROAD AND LOCUST STREET

Right-of-way needs would be limited to that required to install signal hardware. No significant issues expected.

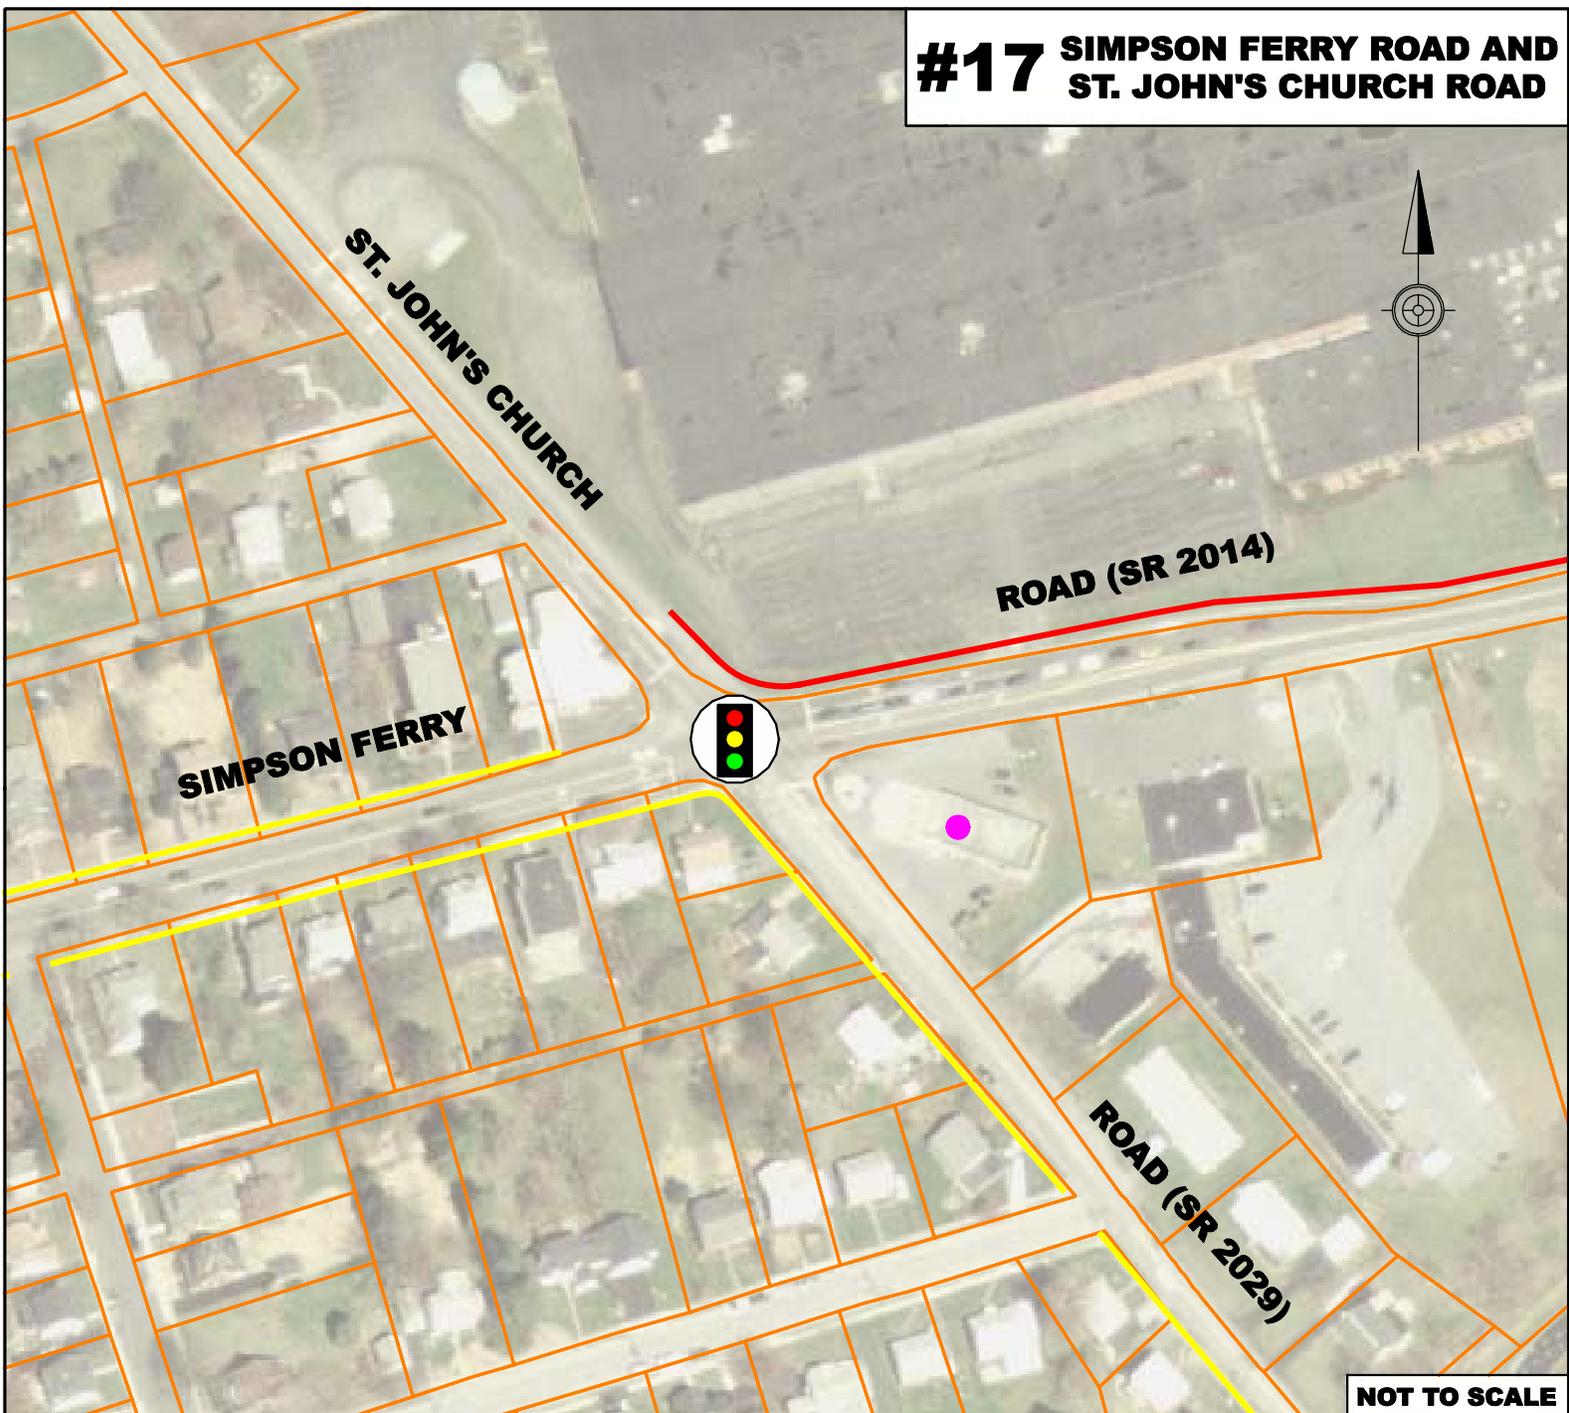
#17 SIMPSON FERRY ROAD AND ST. JOHN'S CHURCH ROAD

IMPROVEMENTS:	NO-BUILD	BUILD	ENVIRONMENTAL/ RIGHT-OF-WAY ISSUES:
	2007		
	C(C)		
	2020		
SHORT TERM:	C(C)	C(C)	Potential hazardous waste - BP Gas No right-of-way anticipated
<ul style="list-style-type: none"> 15 / 581 Improvement Project: Widen westbound Simpson Ferry Road east of St. John's Church Road Improve Signal Timings and Coordination Update pedestrian phase lengths to conform with MUTCD requirements Modify/install crosswalks and curb-cut ramps to conform with ADA requirements 			
LONG TERM:	2030		
<ul style="list-style-type: none"> Improve Signal Timings and Coordination 	D(D)	D(D)

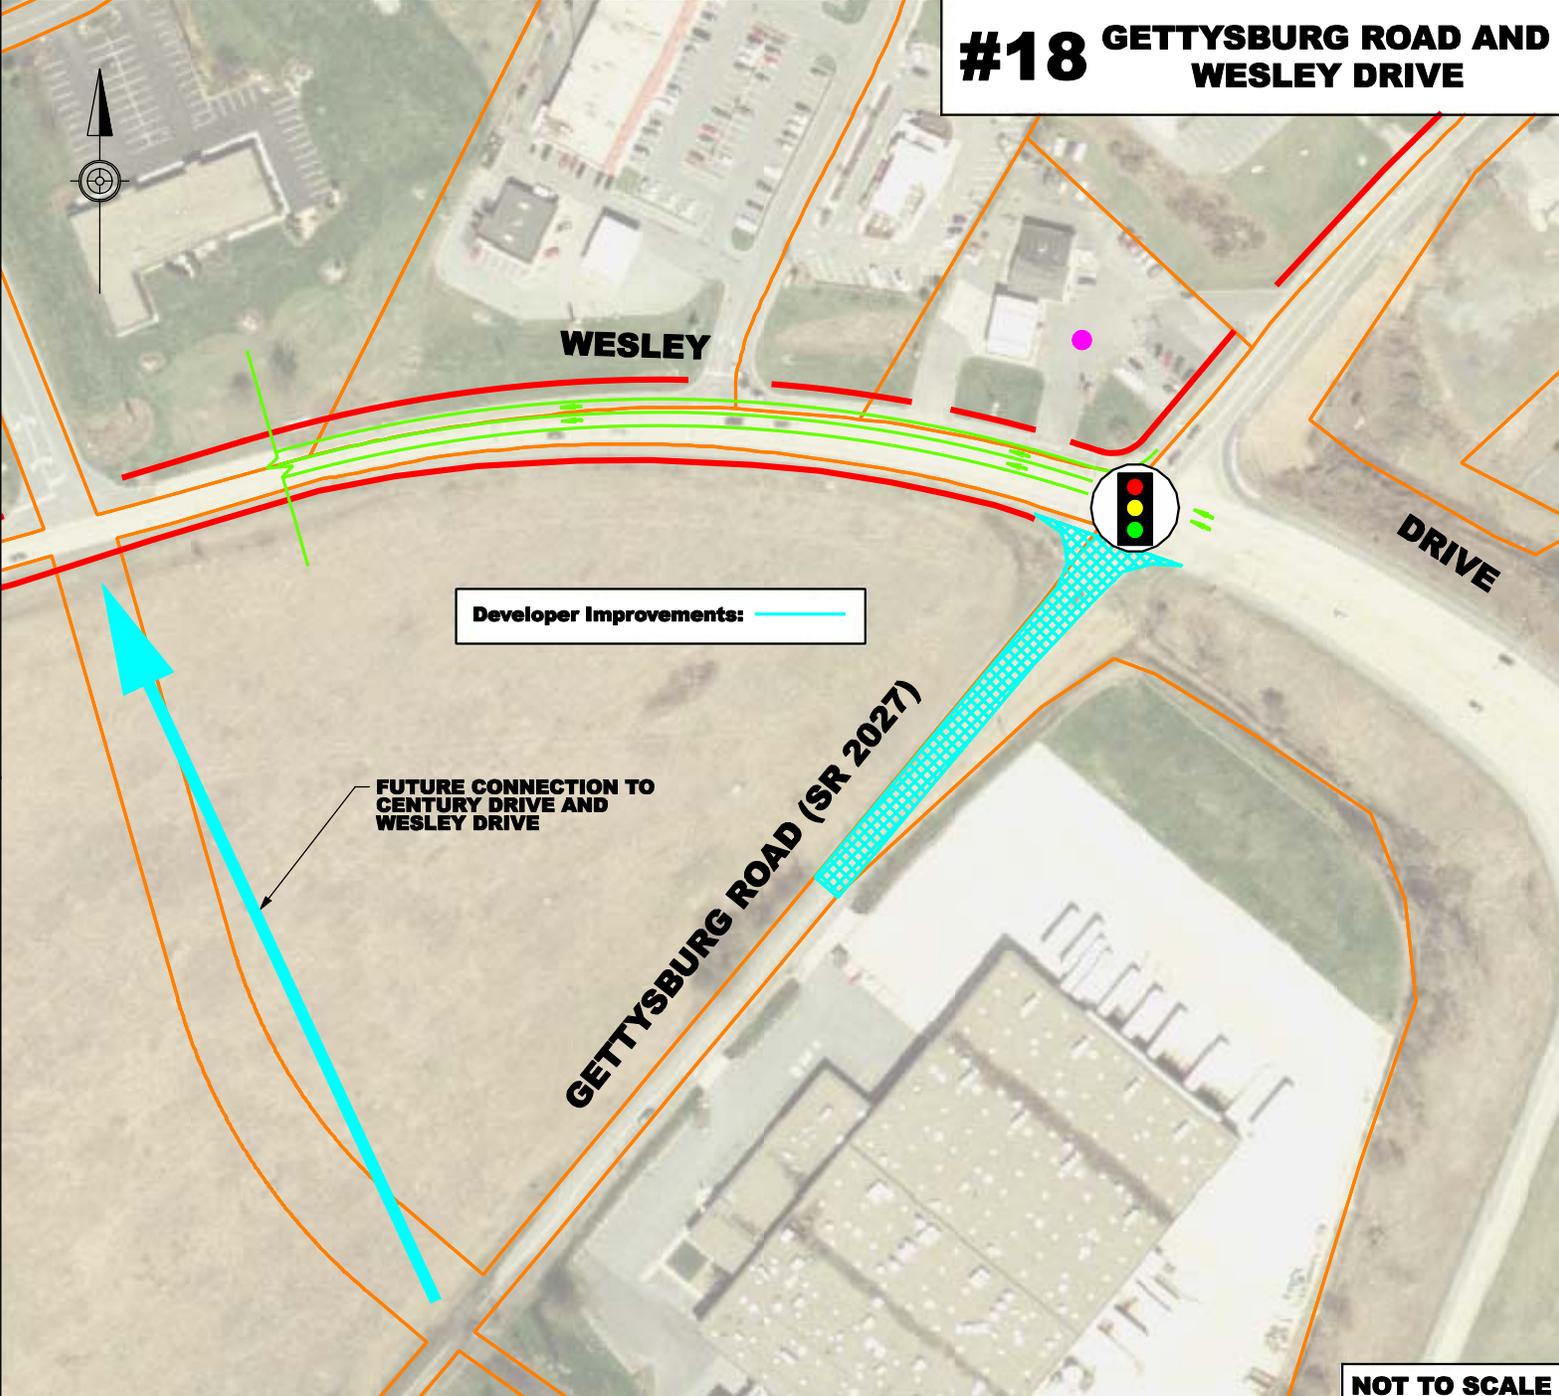
#18 GETTYSBURG ROAD AND WESLEY DRIVE

IMPROVEMENTS:	NO-BUILD	BUILD	ENVIRONMENTAL/ RIGHT-OF-WAY ISSUES:
	2007		
	C(C)		
	2020		
SHORT TERM:	F(D)	B(B)	<p>Potential hazardous waste - BP Gas</p> <p>Right-of-way would be required for widening of Wesley Drive and driveway modification to existing shopping center.</p>
	2030		
LONG TERM:	F(F)	C(C)	
	2030

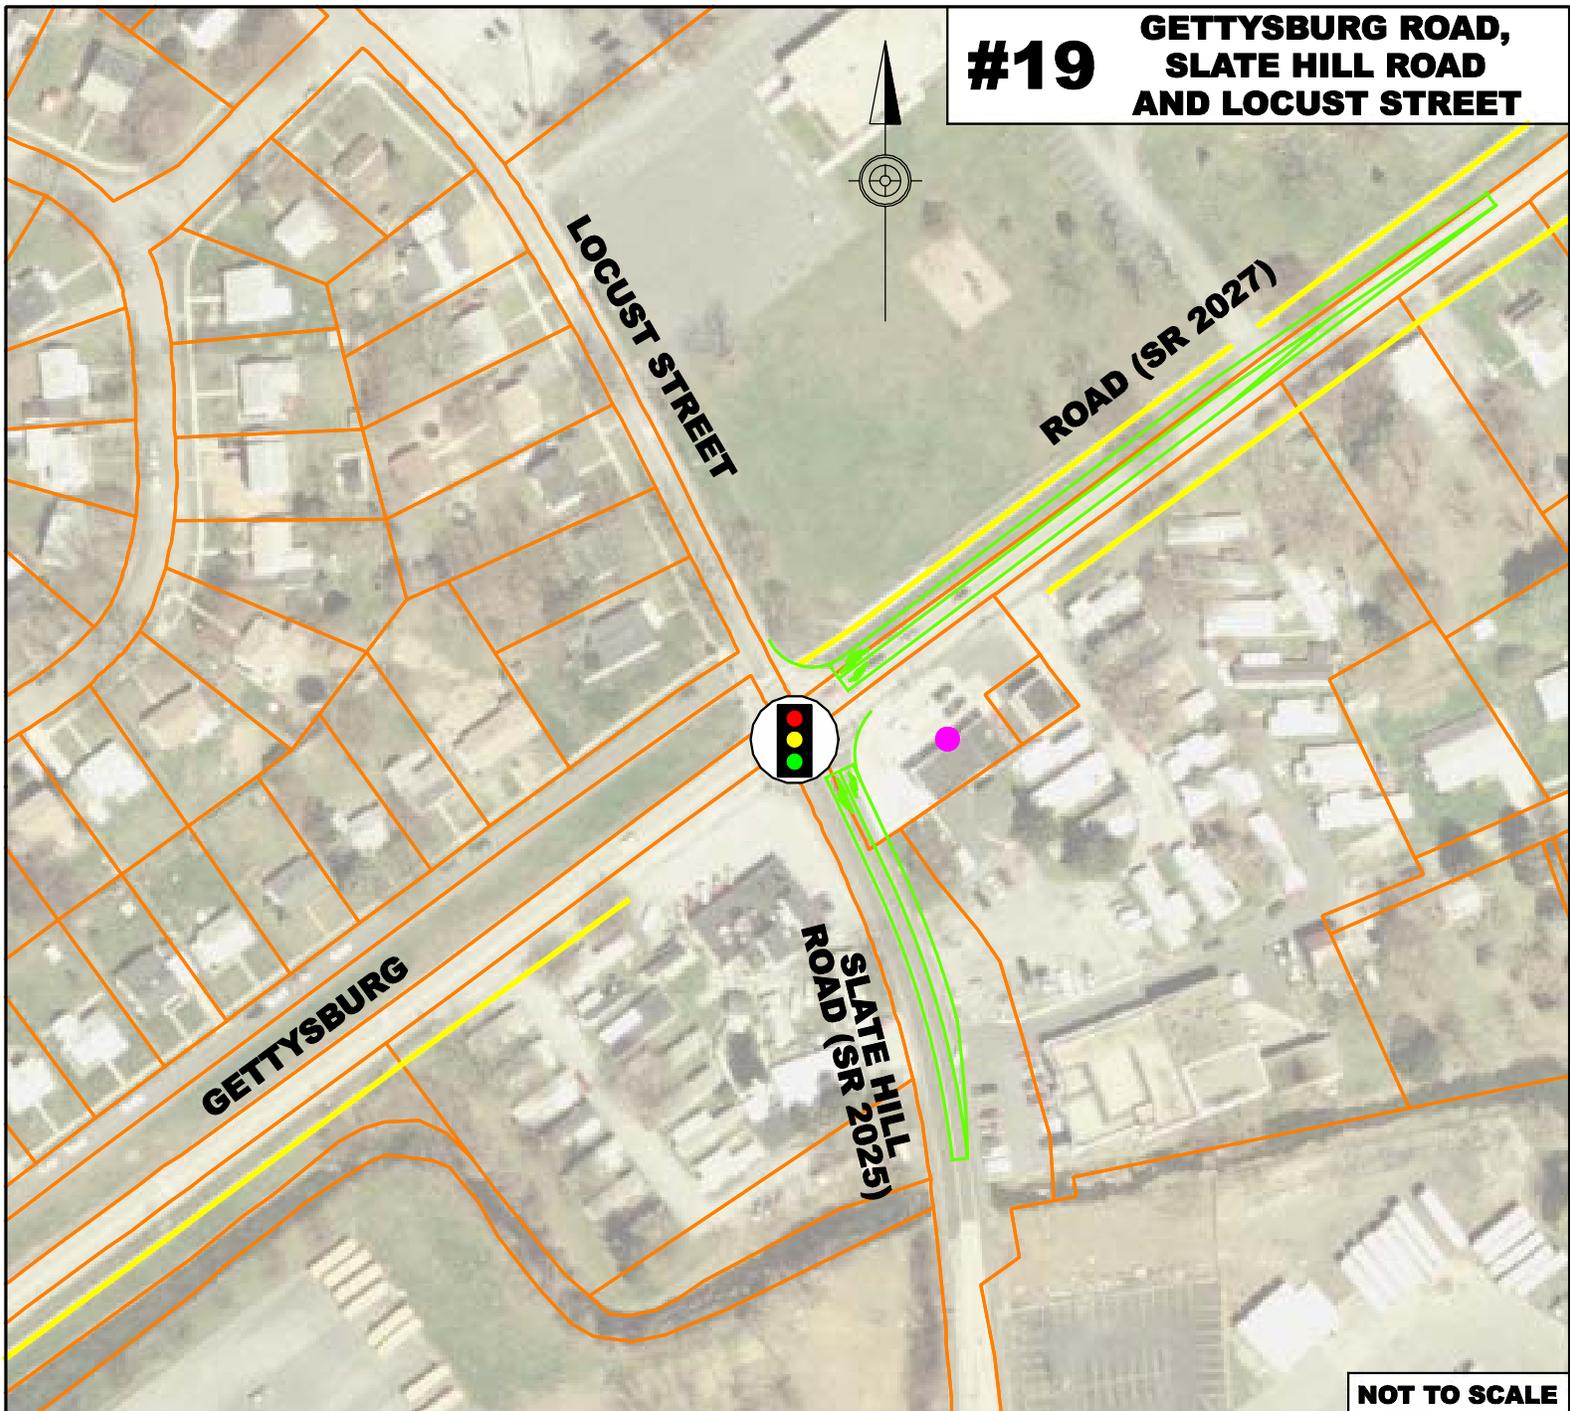
GETTYSBURG ROAD, SLATE HILL ROAD AND LOCUST STREET

Potential hazardous waste-Keystone Service

2020 widening would require right-of-way on the north side of Gettysburg Road and potential displacement of the service station on the southeast quadrant of the intersection.

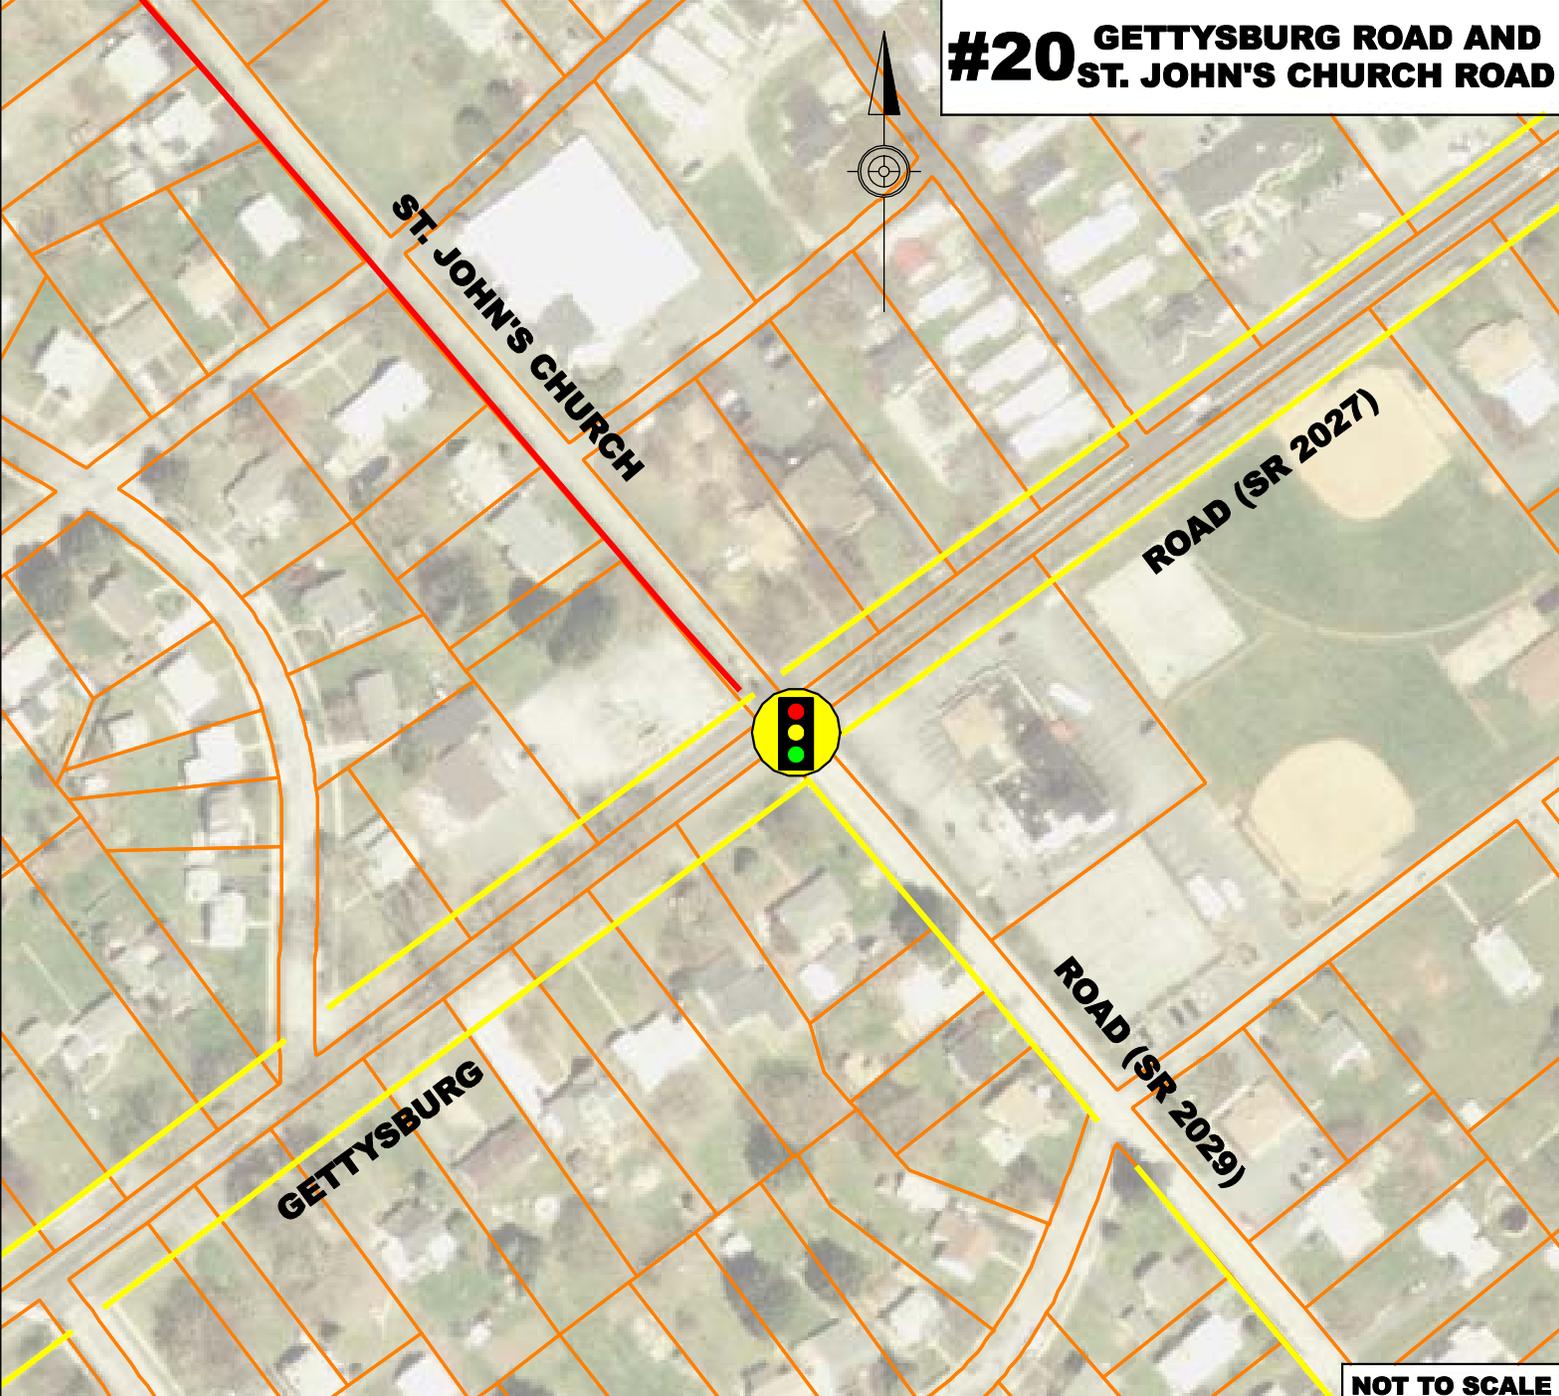
#20 GETTYSBURG ROAD AND ST. JOHN'S CHURCH ROAD

IMPROVEMENTS:	NO-BUILD	BUILD	ENVIRONMENTAL/ RIGHT-OF-WAY ISSUES:
	2007		
	D(E)		
	2020		
SHORT TERM:	F(F)	B(B)	<p>No environmental issues of note</p> <p>No right-of-way issues anticipated</p>
<ul style="list-style-type: none"> Install two-phase traffic signal Improve Signal Timings and Coordination Program pedestrian phase lengths to conform with MUTCD requirements Install crosswalks and curb-cut ramps to conform with ADA requirements 			
LONG TERM:	2030		
<ul style="list-style-type: none"> Improve Signal Timings and Coordination 	F(F)	D(C)

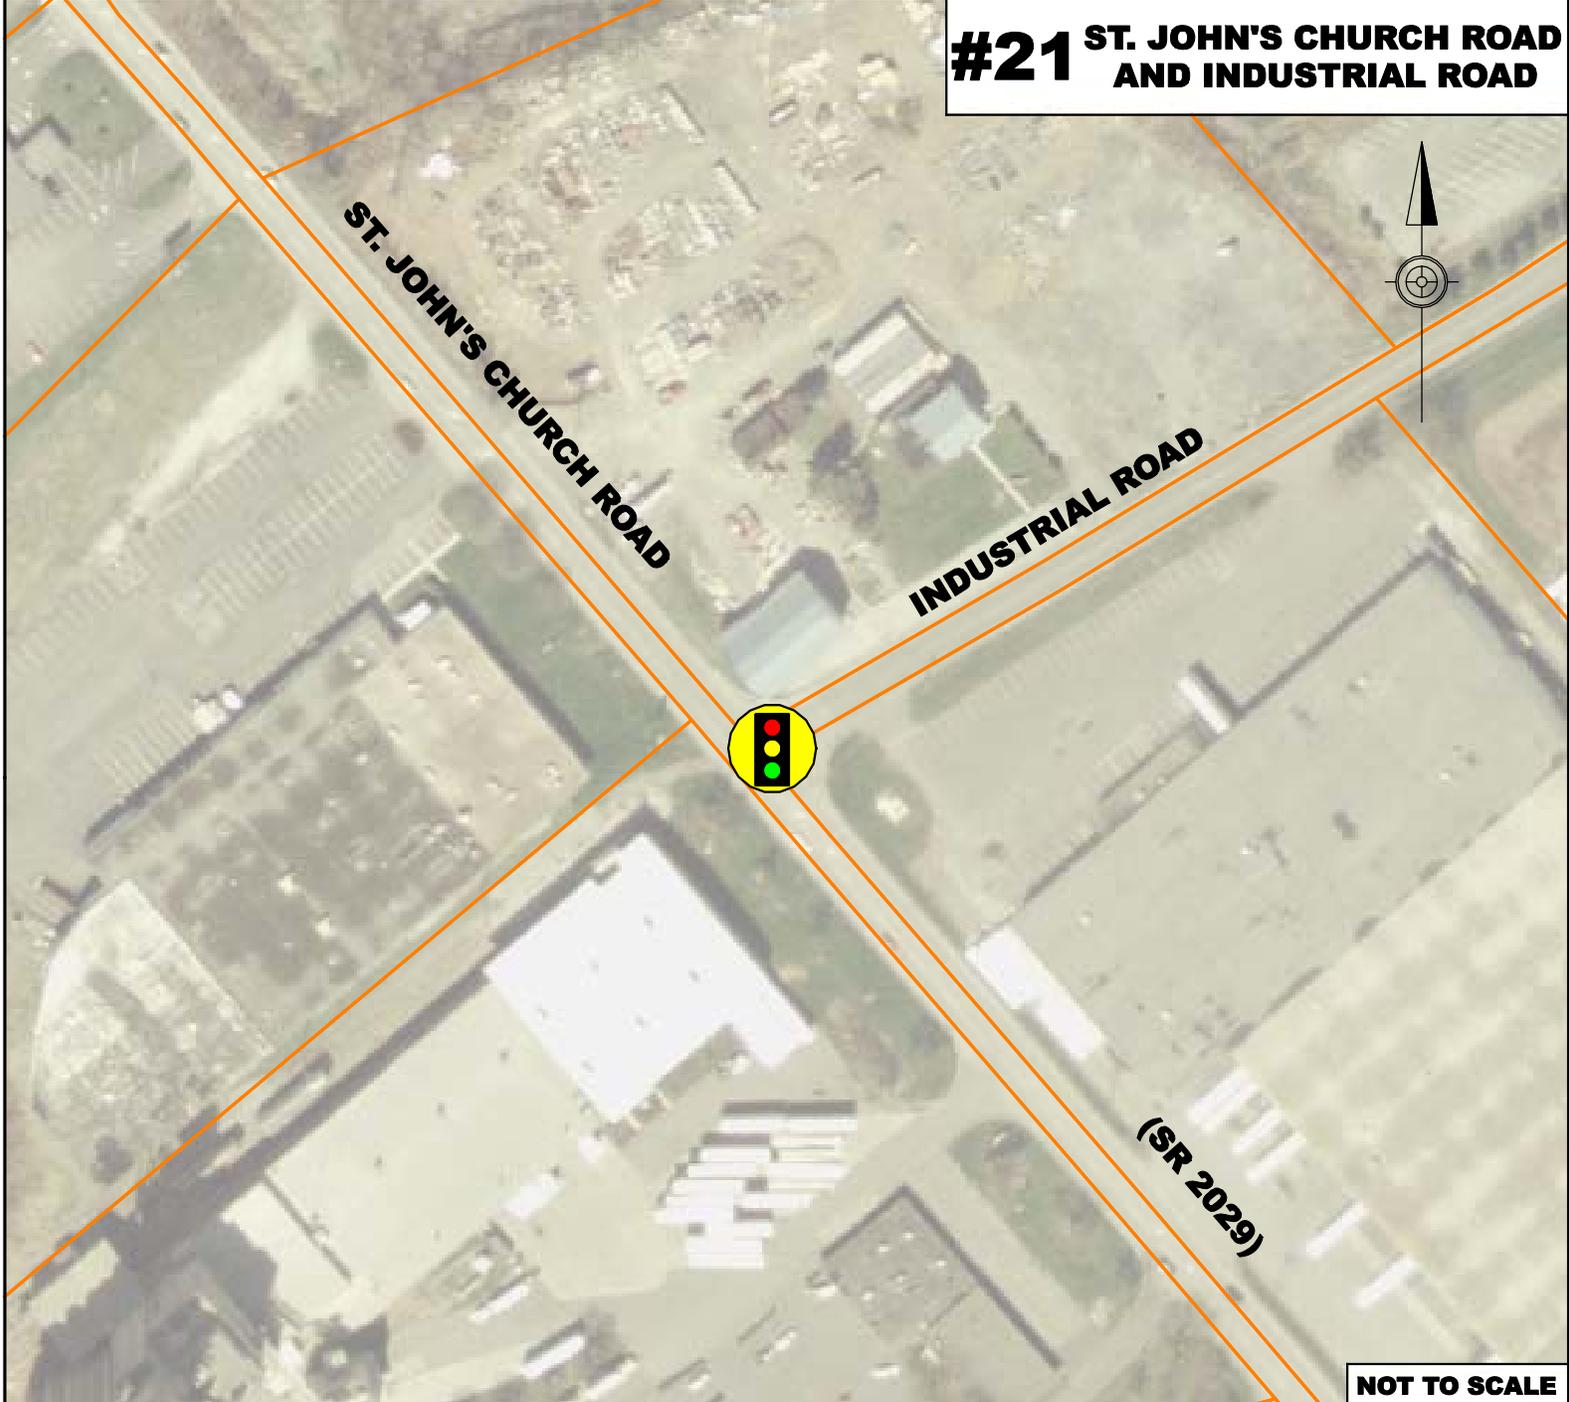
#21 ST. JOHN'S CHURCH ROAD AND INDUSTRIAL ROAD

IMPROVEMENTS:	NO-BUILD	BUILD	ENVIRONMENTAL/ RIGHT-OF-WAY ISSUES:
	2007		
	F(F)		
	2020		
SHORT TERM:	F(F)	B(B)	<p>No environmental issues of note</p> <p>No right-of-way required expect for signal hardware requirements.</p>
<ul style="list-style-type: none"> Install three-phase traffic signal Improve Signal Timings and Coordination Program pedestrian phase lengths to conform with MUTCD requirements Install crosswalks and curb-cut ramps to conform with ADA requirements 			
LONG TERM:	2030		
<ul style="list-style-type: none"> Improve Signal Timings and Coordination 	F(F)	B(B)

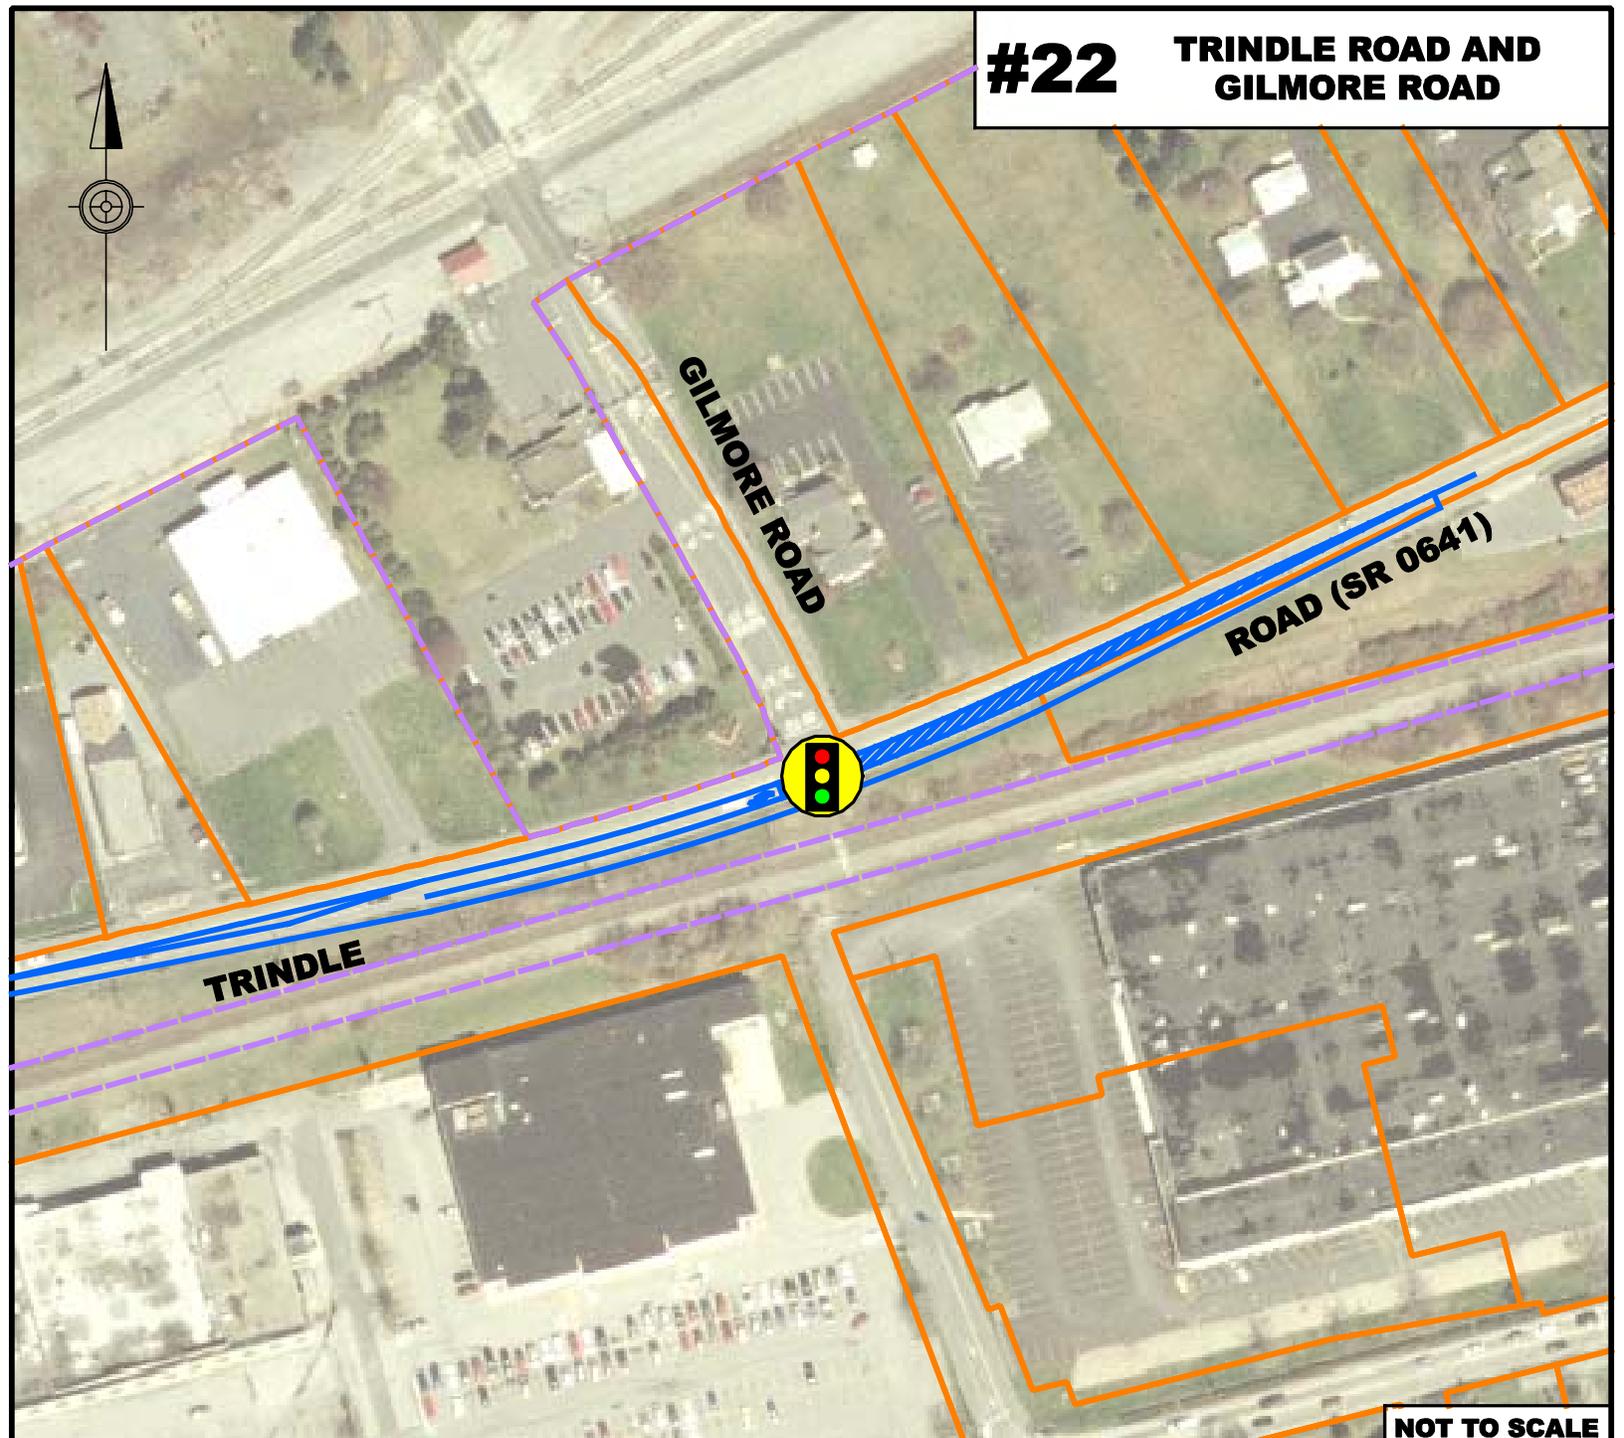
#22 TRINDLE ROAD AND GILMORE ROAD

IMPROVEMENTS:	NO-BUILD	BUILD	ENVIRONMENTAL/ RIGHT-OF-WAY ISSUES:
	2007		
IMMEDIATE:	C(D)		
SHORT TERM:	2020		
<ul style="list-style-type: none"> Consider signaling to mitigate PM Peak level-of-service deficiencies (LOS E) on stop-controlled approach 	D(E)	D(E)	
	2030		
LONG TERM:	F(F)	B(B)	
<ul style="list-style-type: none"> Install three-phase traffic signal Add 260' left-turn lane on eastbound Trindle Road Improve Signal Timings and Coordination 			<p>Potential Historic Resource - Navy Depot</p> <p>National Register Eligible Resource - Cumberland Valley Railroad</p> <p>Right-of-way would be required for 2030 improvements which would require interaction with the railroad which might be problematic. Clearance requirements of the RR should be incorporated early in the design process.</p>

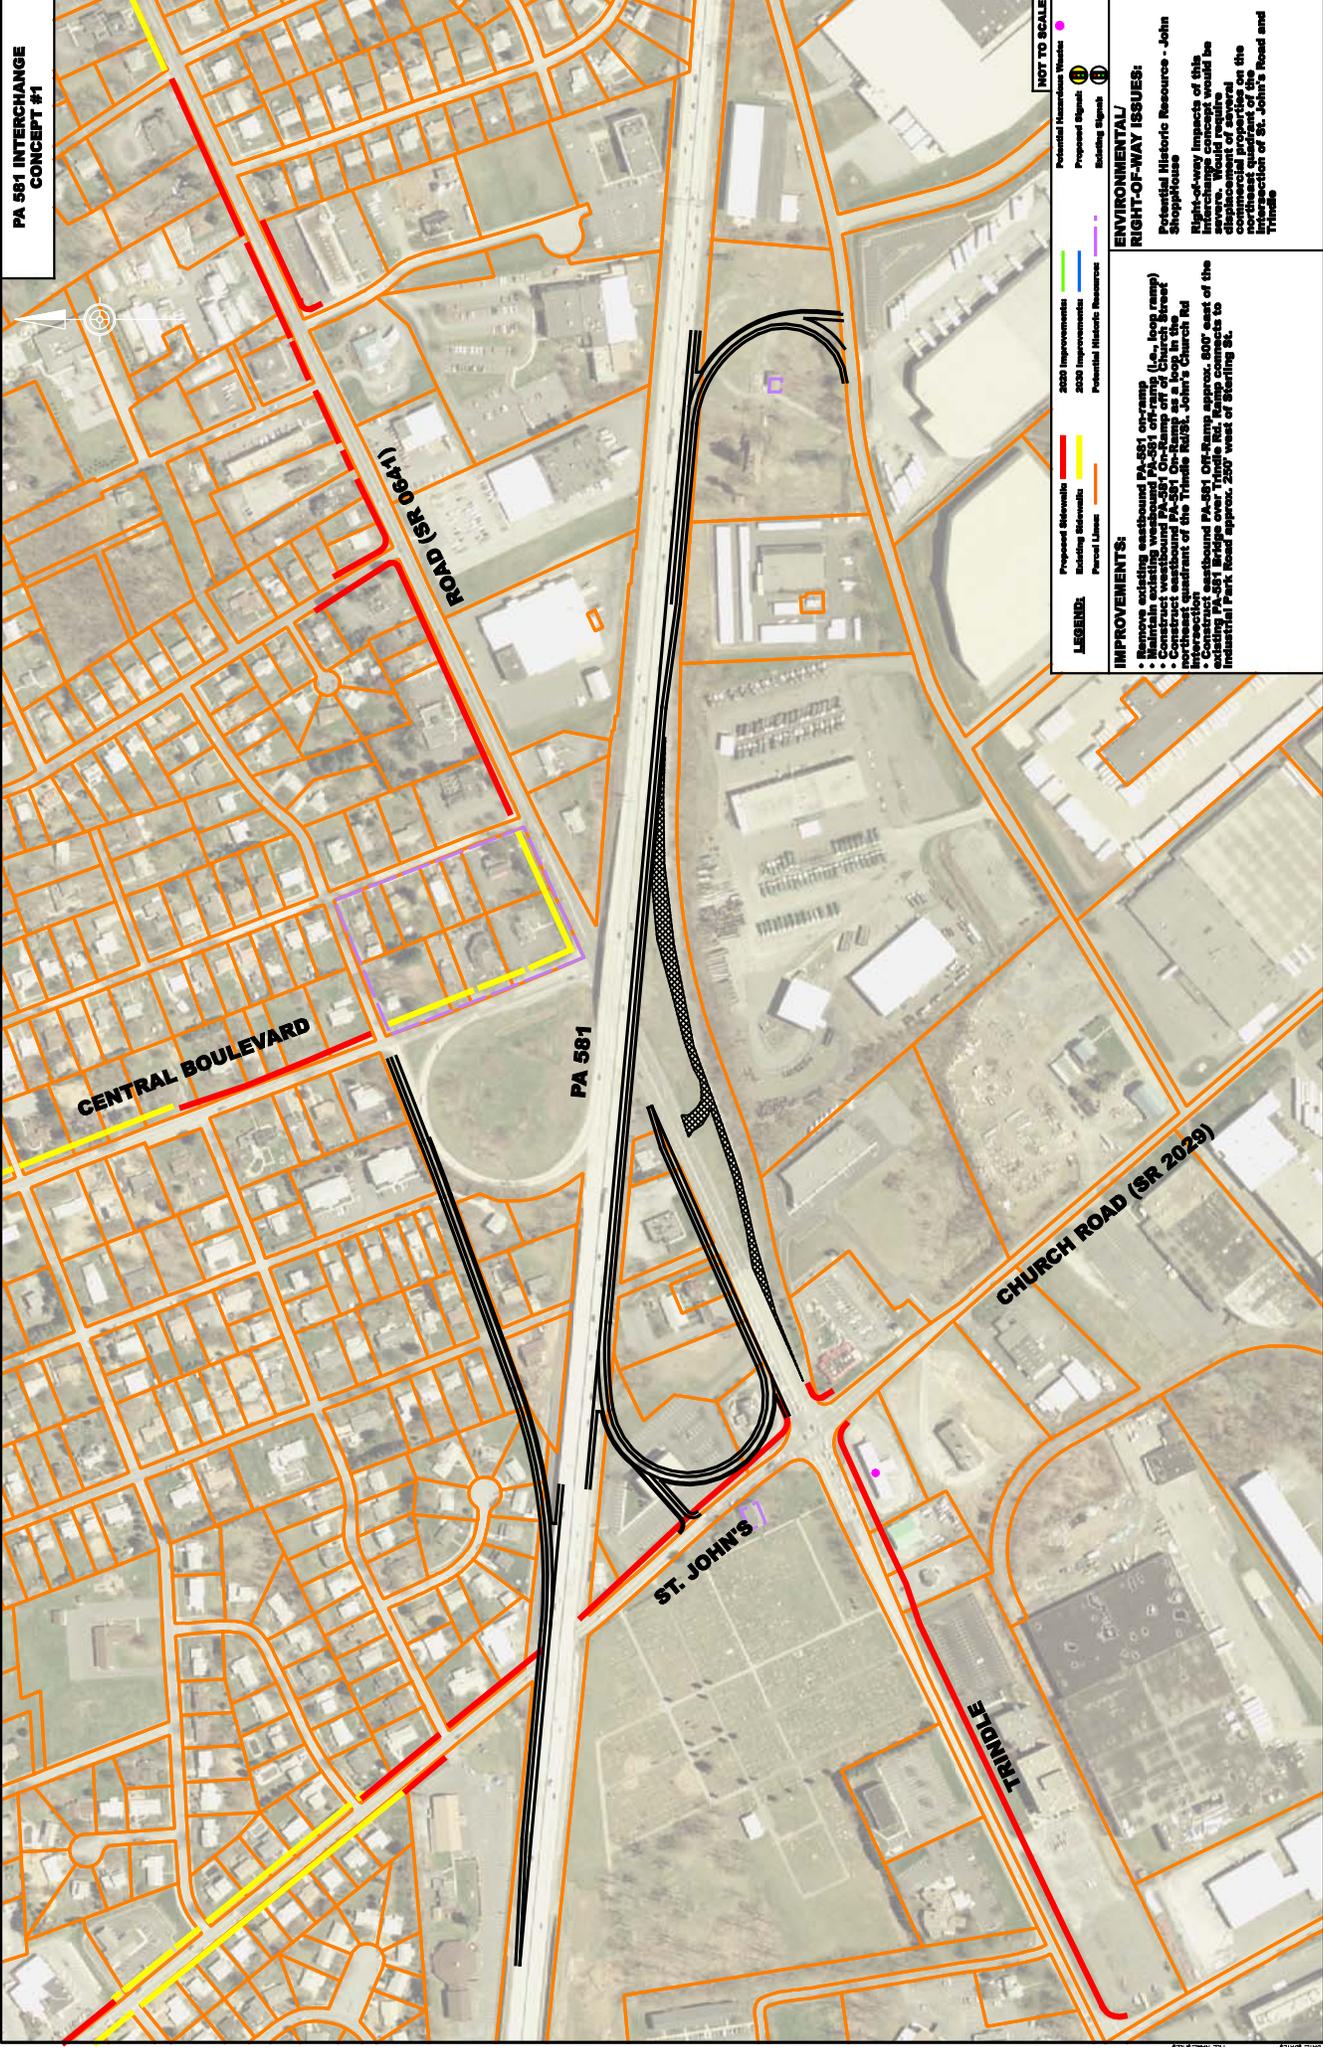
**PA 581 INTERCHANGE
CONCEPT #1**

- Remove existing eastbound PA-581 on-ramp
- Construct eastbound PA-581 On-Ramp off of Church Street
- Construct westbound PA-581 On-Ramp as a loop in the intersection of the Trindle RAMP, John's Church Rd
- Construct eastbound PA-581 Off-Ramp approx. 800' east of the intersection of Church Road and Trindle. This ramp leads to Industrial Park Road approx. 200' west of Spaulding St.
