# **THE MEADOWS**

**APPENDIX 30 – LOCAL IMPACT  
REPORT**

This Local Impact Report has been prepared in connection with an application to the Pennsylvania Gaming Control Board by Washington Trotting Association, Inc. to be licensed as a Conditional Category 1 Slot Machine Operator.

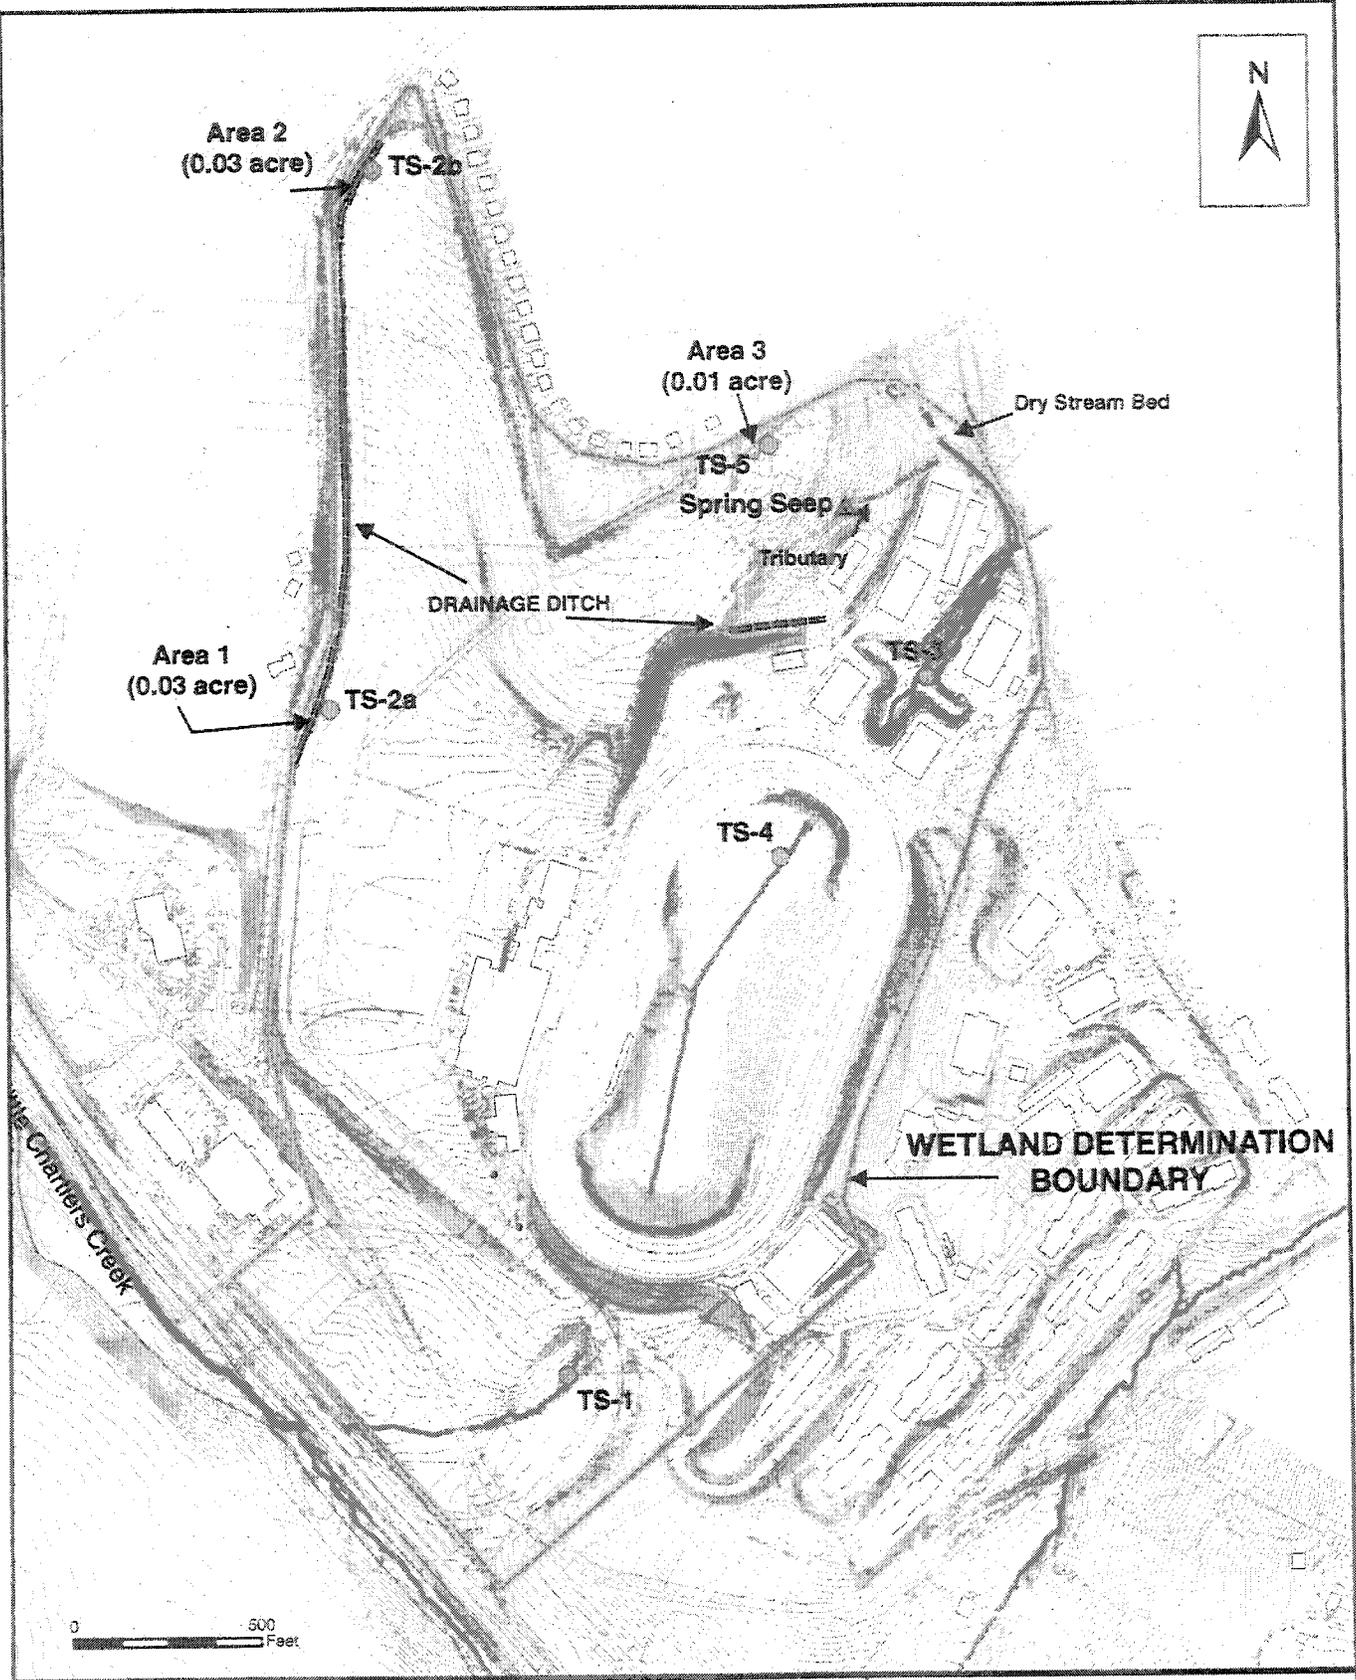
Appendix A and photographs are provided in Appendix B. CEC also noted other potential jurisdictional waters (streams, lakes, drainages). The locations of the test sites and the approximate location and extent of potential wetlands and other jurisdictional waters are shown on Figure 2.

Wetland hydrology indicators were observed at Test Site 2a/b and at Test Site 5. Specific hydrology indicators observed within the wetland communities are provided on the wetland determination forms (Appendix A).

If development activities are proposed for the TS-5 area and or any of the onsite tributaries then CEC would recommend that a wetland delineation and stream determination be conducted. CEC would also recommend a site visit with the DEP and the Corps to verify and determine if any of the potential wetland areas, unnamed tributary, or feeder tributaries would be considered jurisdictional and regulated at the state or federal level. The intent of the meeting would be to gain a clearer understanding of each agency's view of the jurisdictional status and associated permitting requirements (if any) for any potential jurisdictional waters.

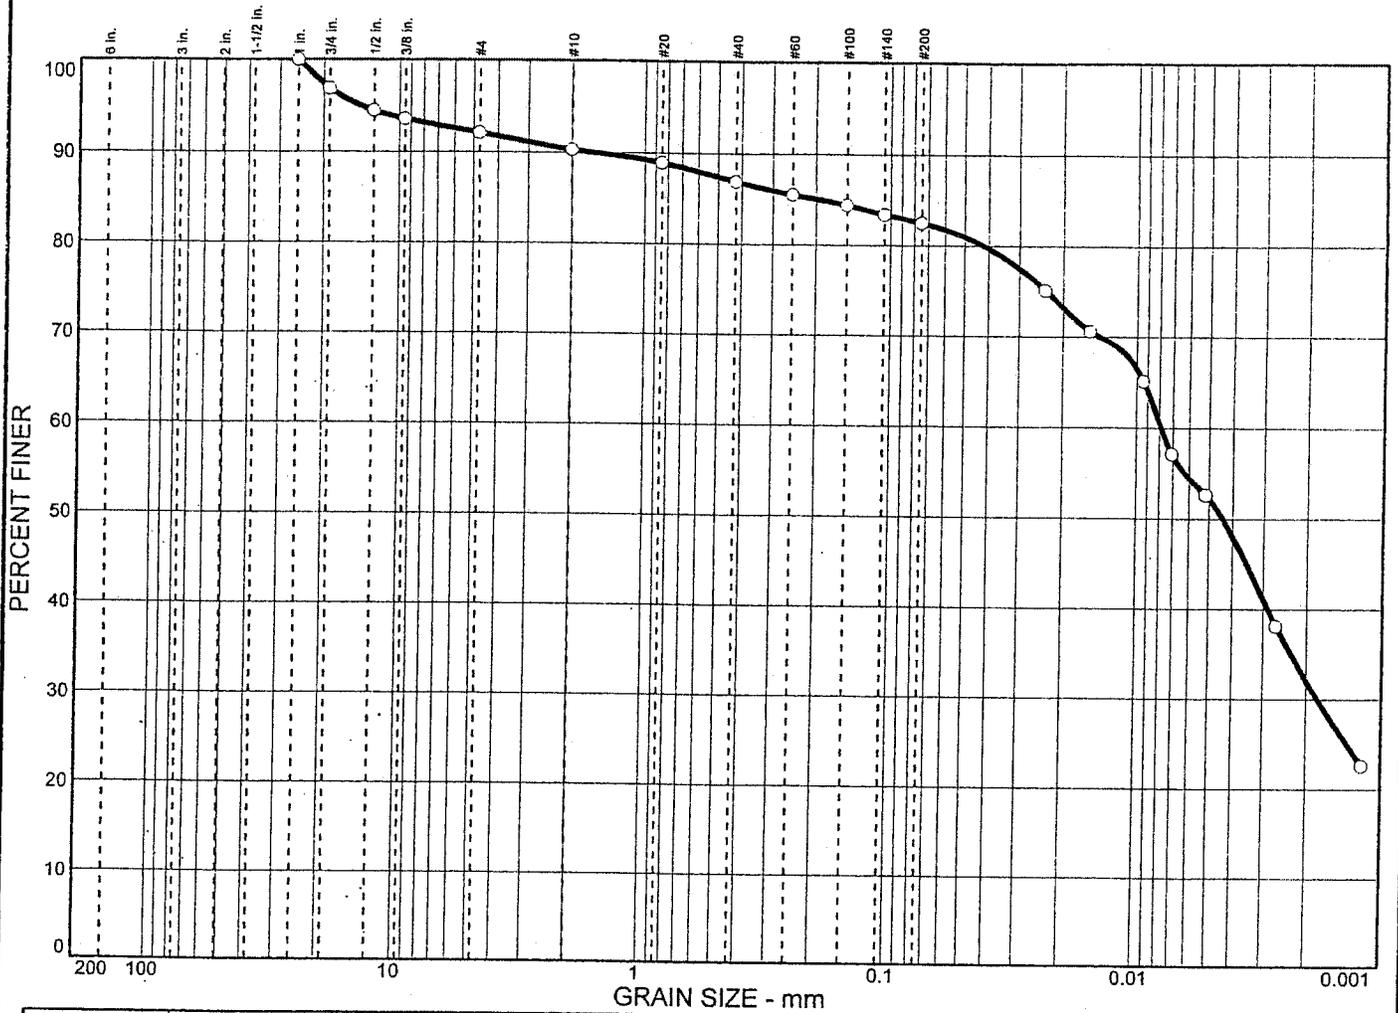
# PARTICLE SIZE DISTRIBUTION TEST REPORT

% COBBLES	% GRAVEL	% SAND	% SILT	% CLAY
0.0	7.9	9.6	30.3	52.2

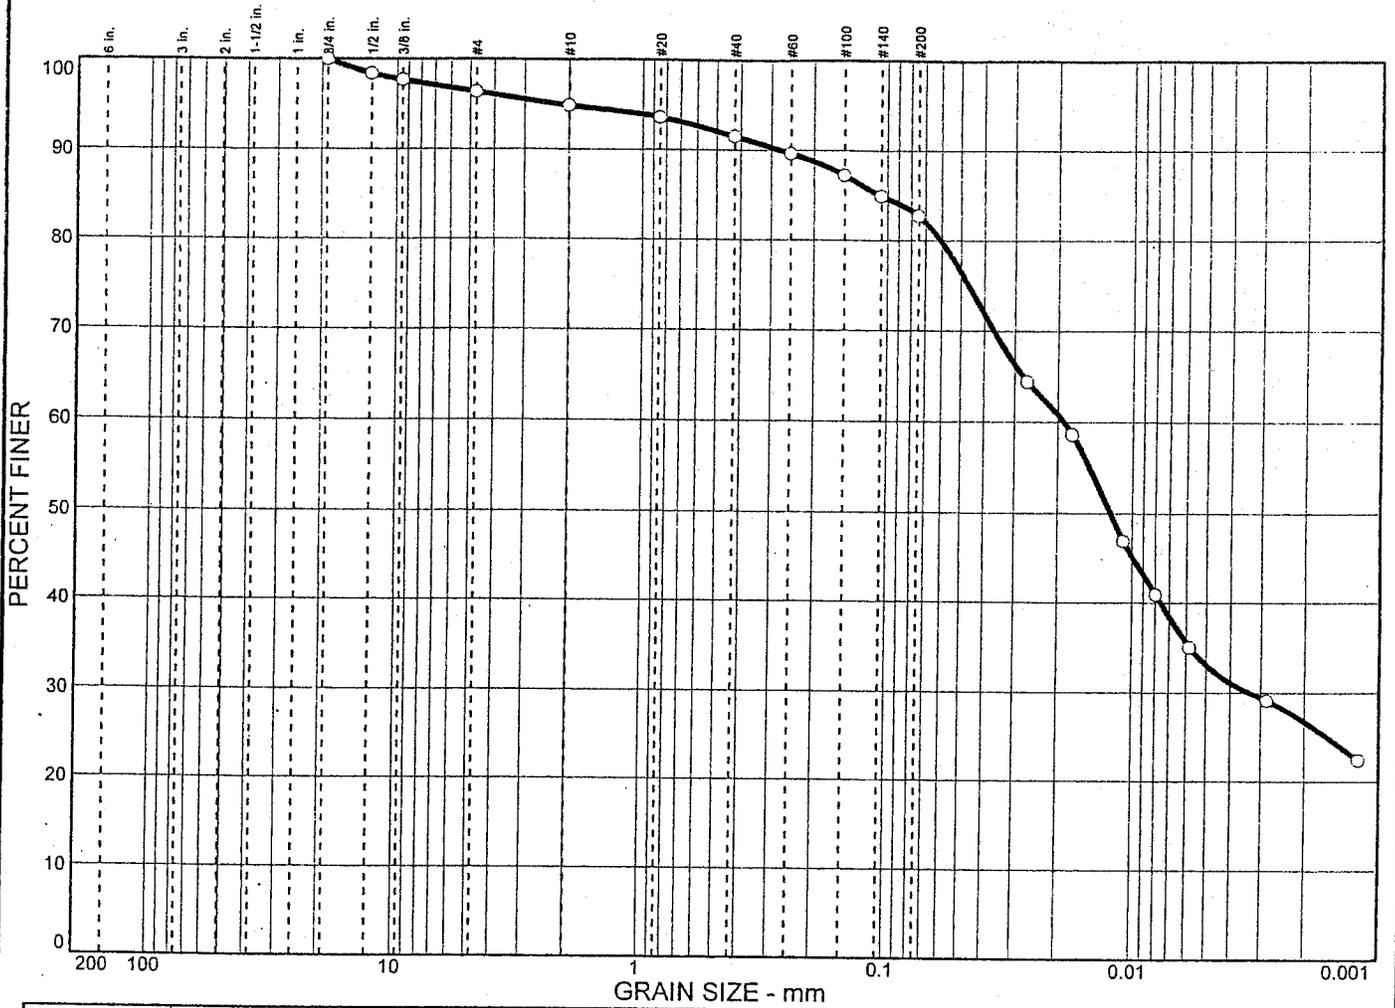
# PARTICLE SIZE DISTRIBUTION TEST REPORT

% COBBLES	% GRAVEL	% SAND	% SILT	% CLAY
0.0	3.6	13.7	49.7	33.0

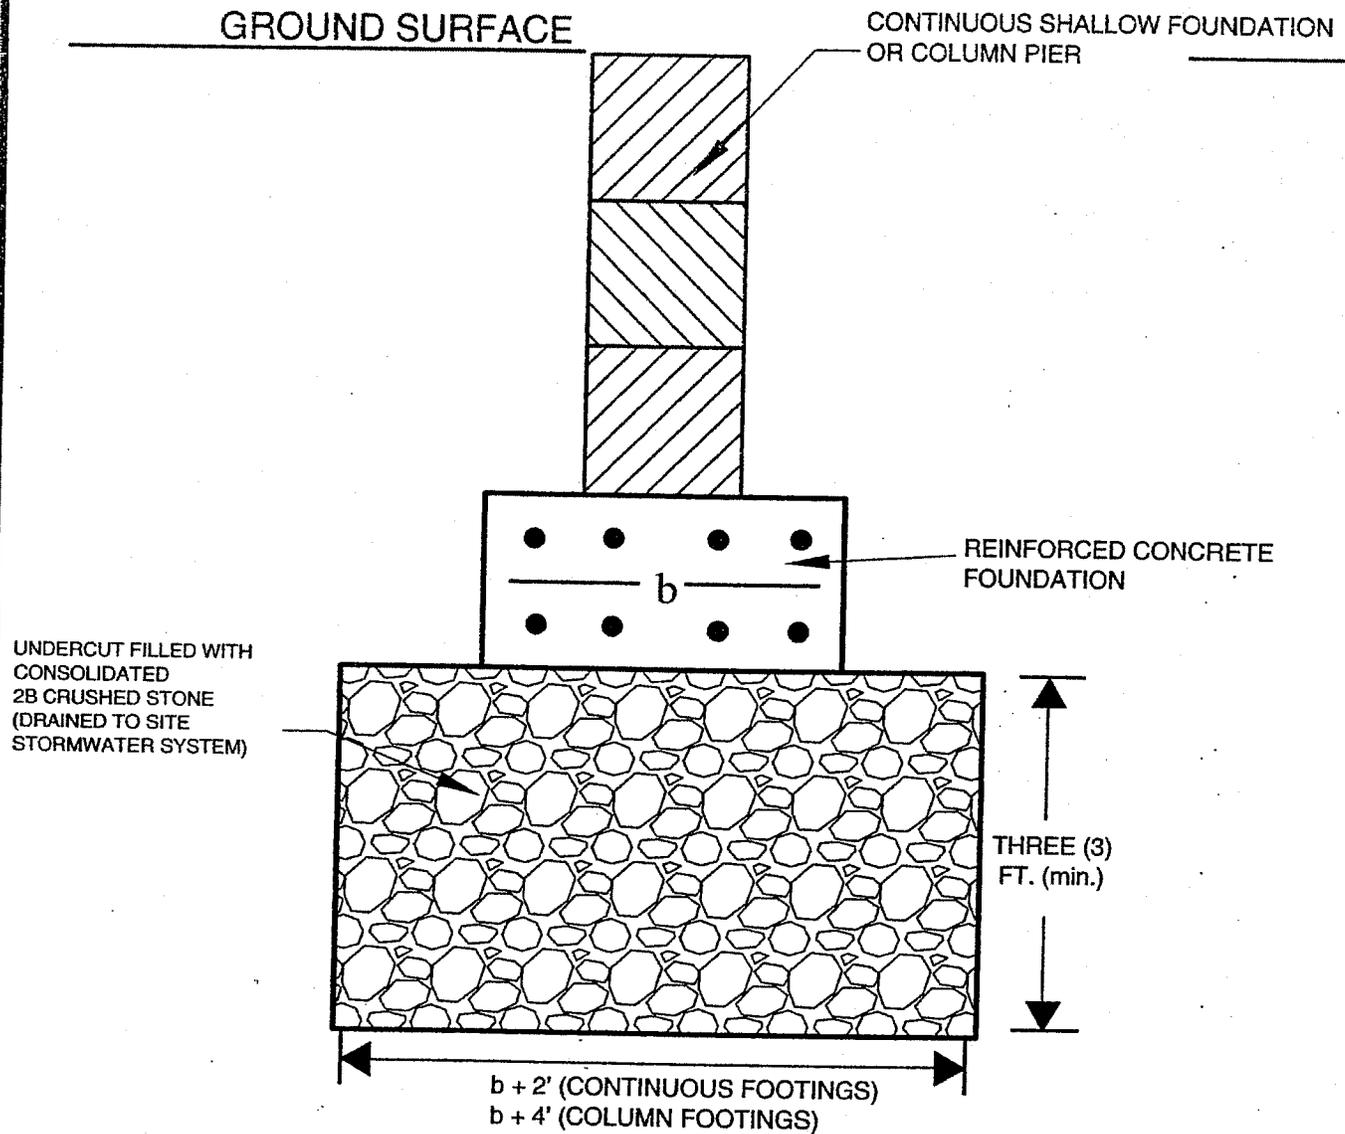
# MEADOWS PADDOCK BARN

## FOUNDATION UNDERCUT IN EXISTING FILL

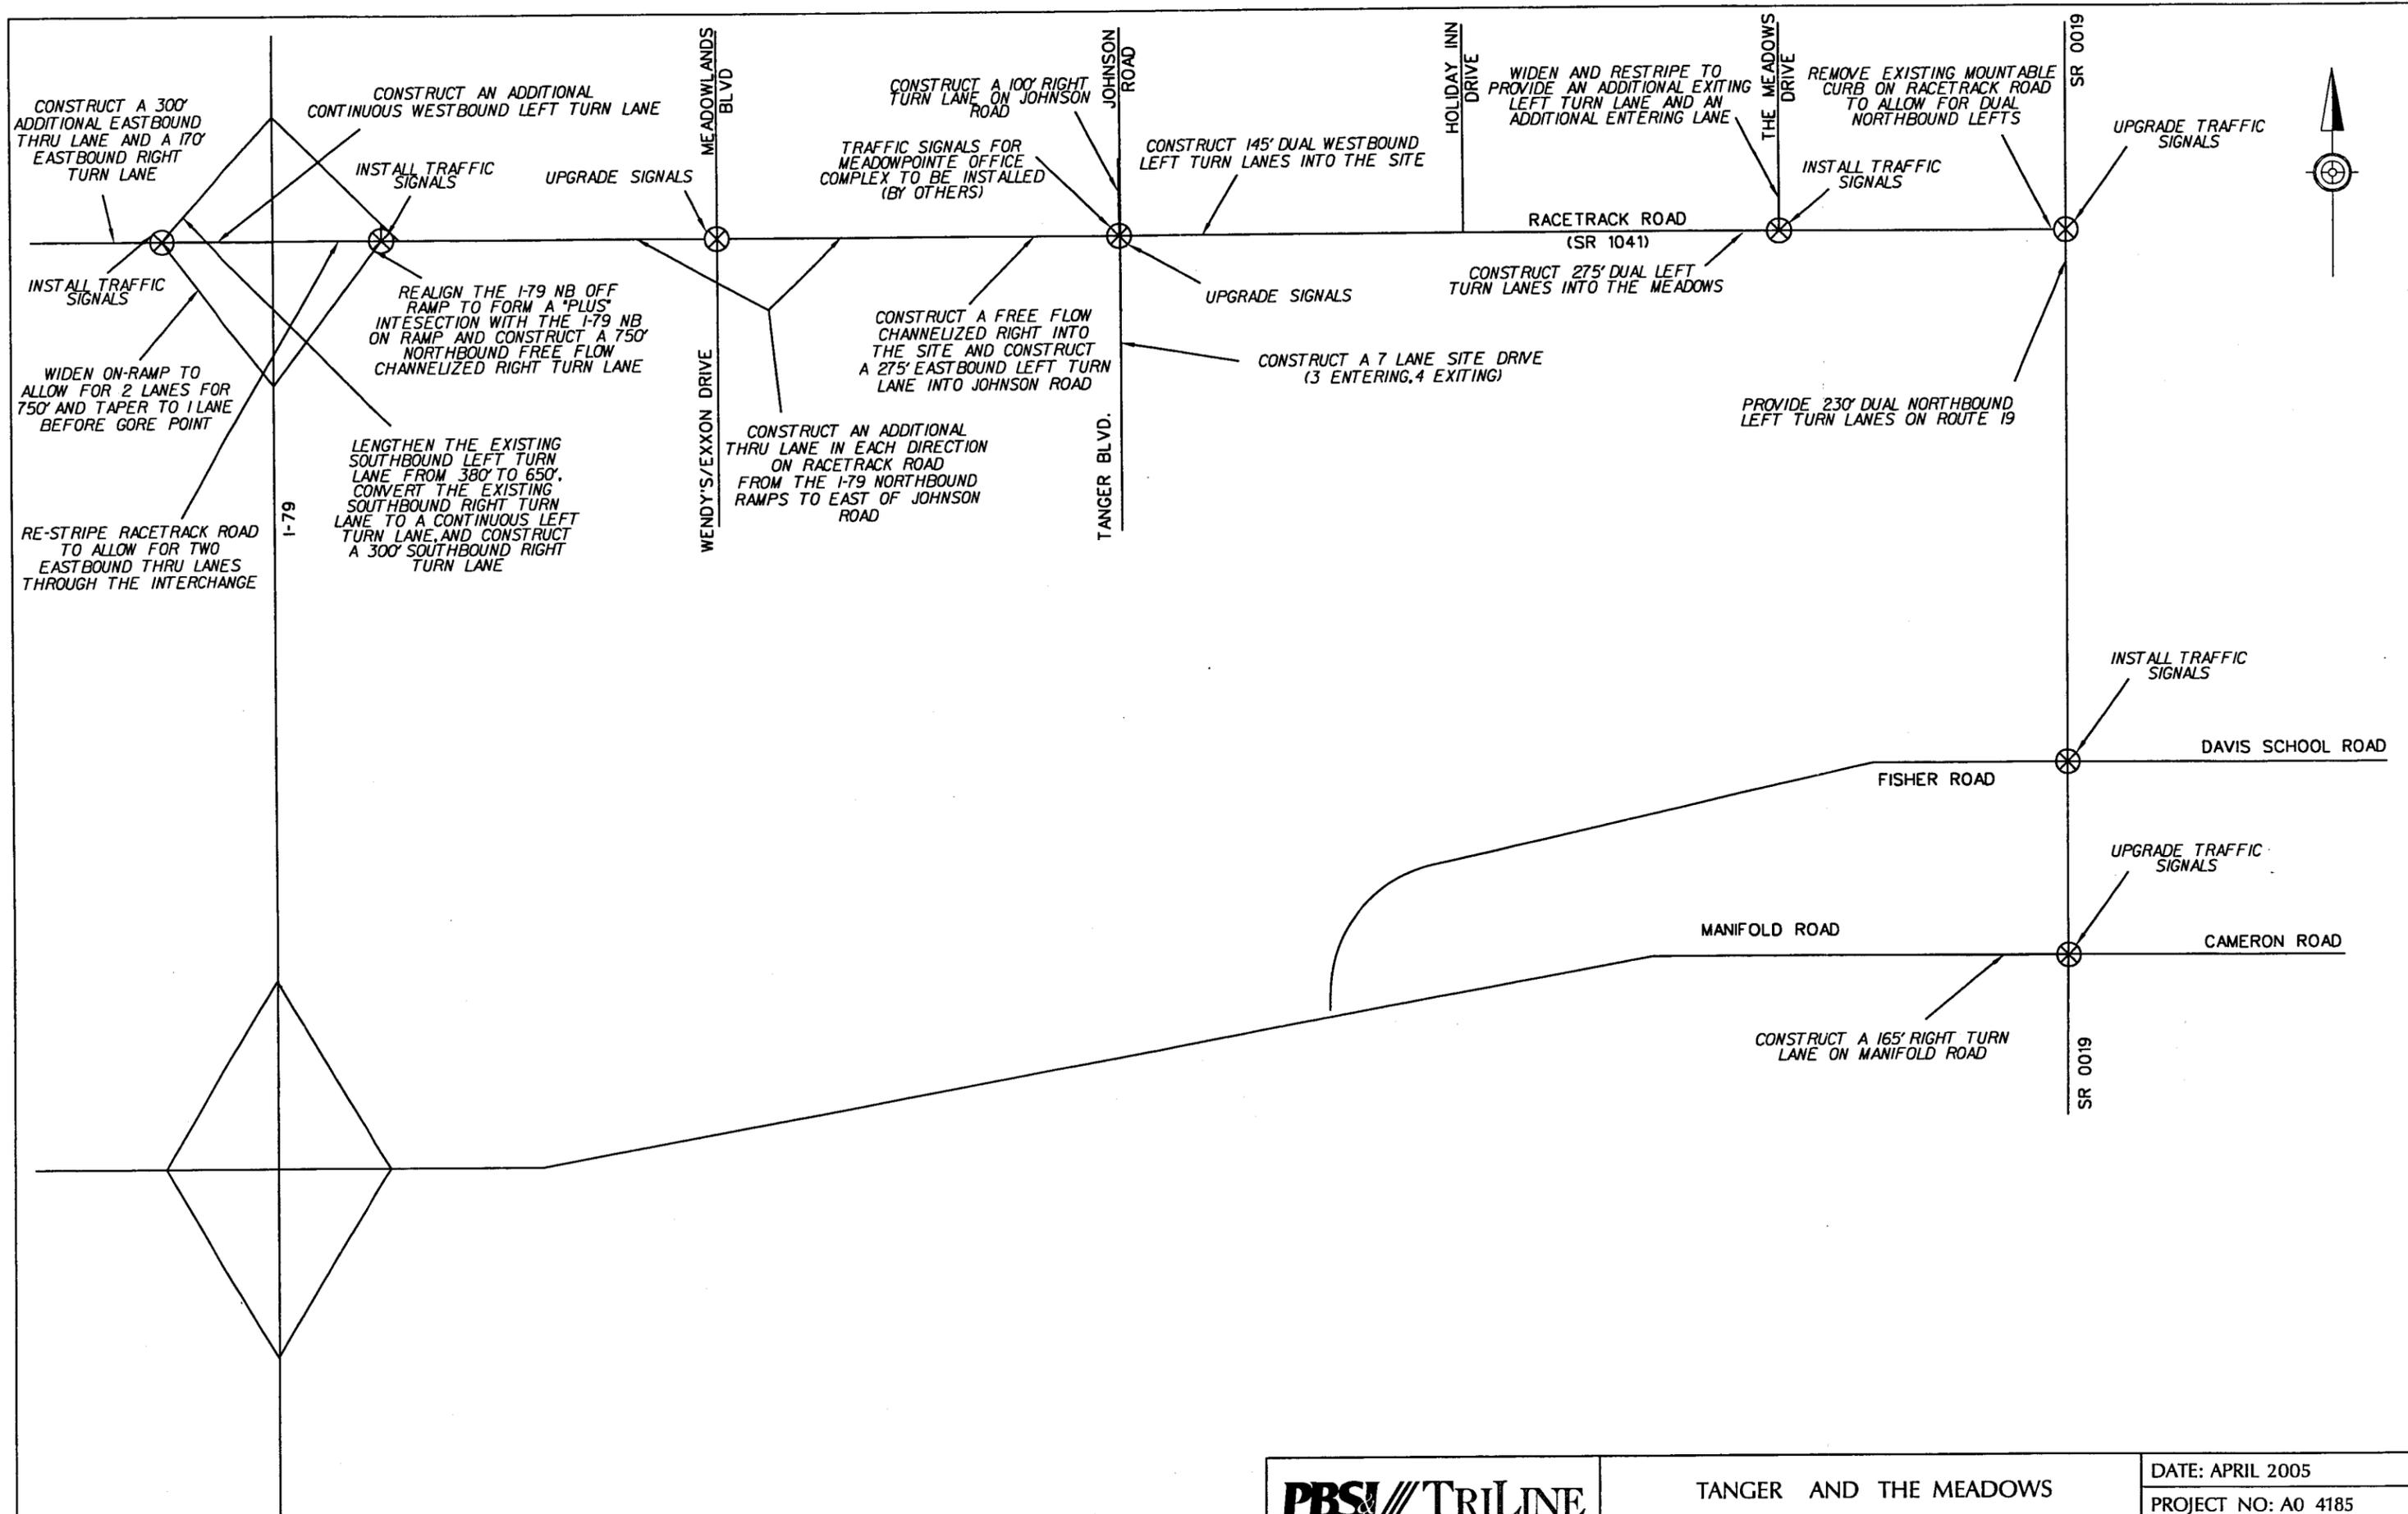
<b>PBSJ // TrILINE</b> 400 TECHNOLOGY DRIVE, SUITE 100 CANONSBURG, PA 15317	<b>TANGER AND THE MEADOWS</b>		DATE: APRIL 2005	
	REQUIRED MITIGATION - BUILD CONDITIONS W/TANGER FACTORY OUTLET AND THE MEADOWS		PROJECT NO: A0 4185	
		DRA: JPD	CHK: VGY	
		FIGURE: 4	SCALE: NONE

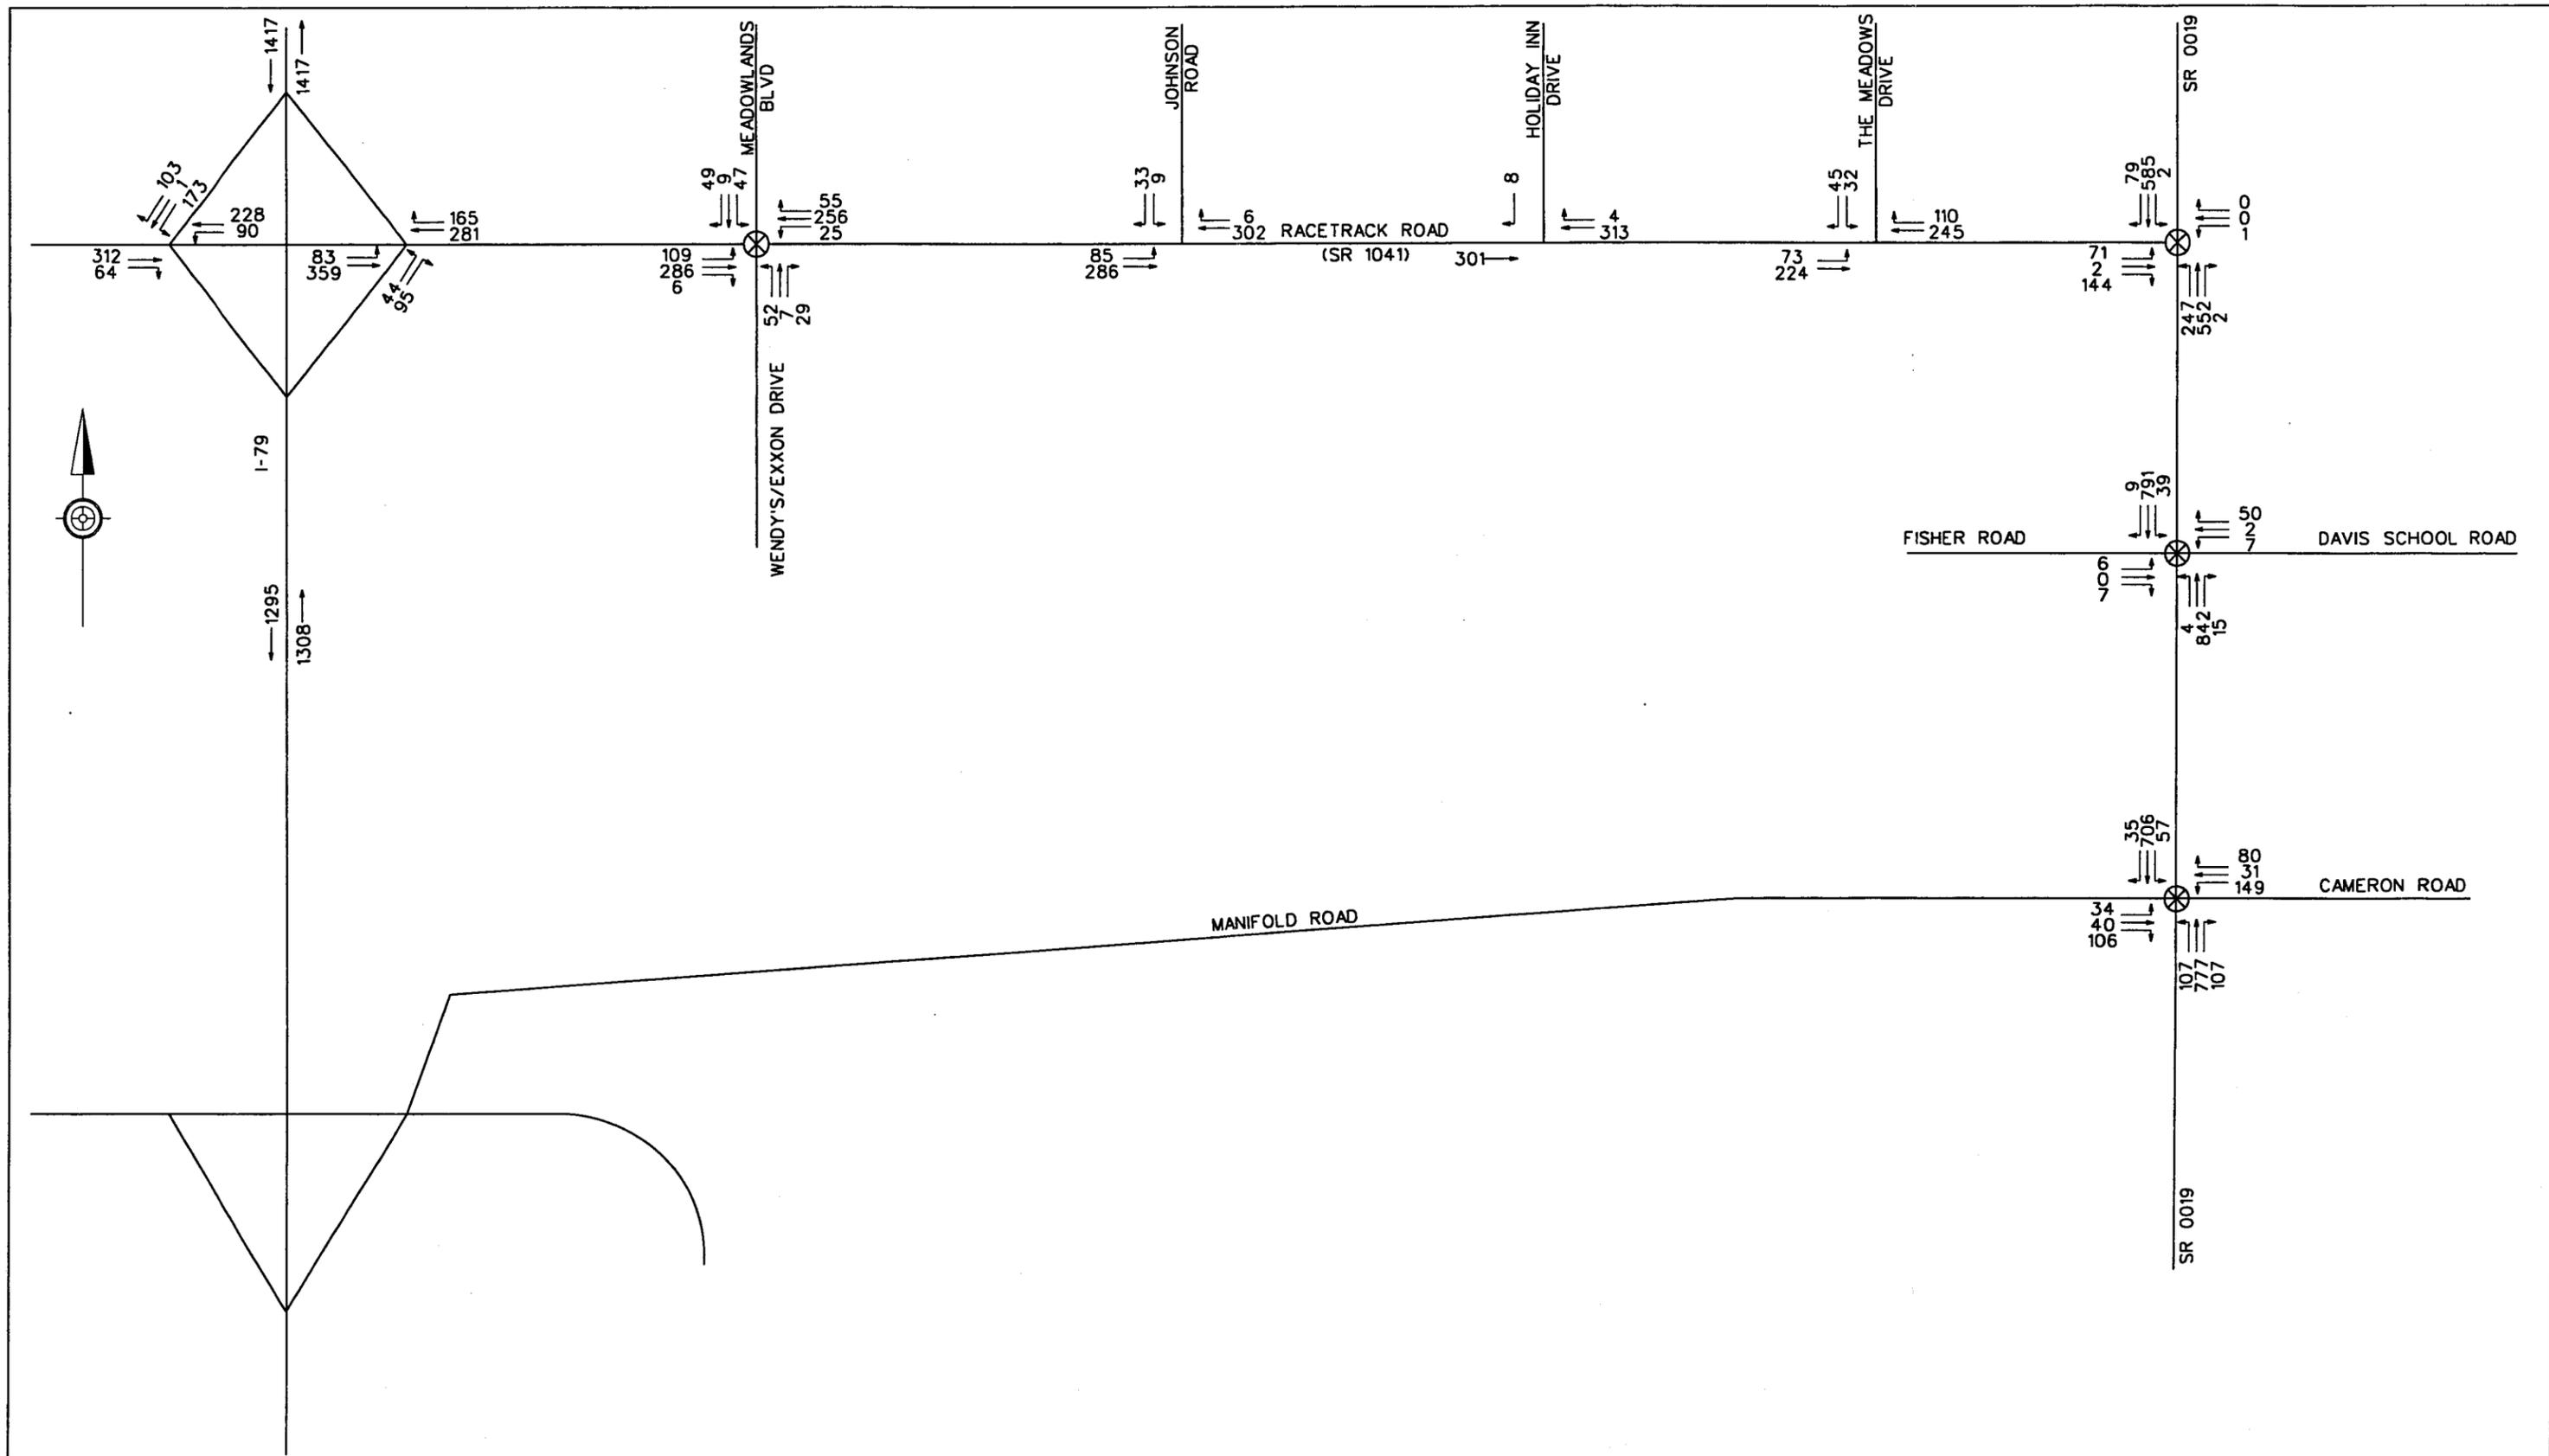
<b>PBSJ // TRILINE</b> 400 TECHNOLOGY DRIVE, SUITE 100 CANONSBURG, PA 15317	TANGER AND THE MEADOWS		DATE: APRIL 2005	
	PROJECTED 2006 SATURDAY PEAK HOUR TRAFFIC VOLUMES		DRA: JPD	CHK: VGY
			FIGURE: 8	SCALE: NONE

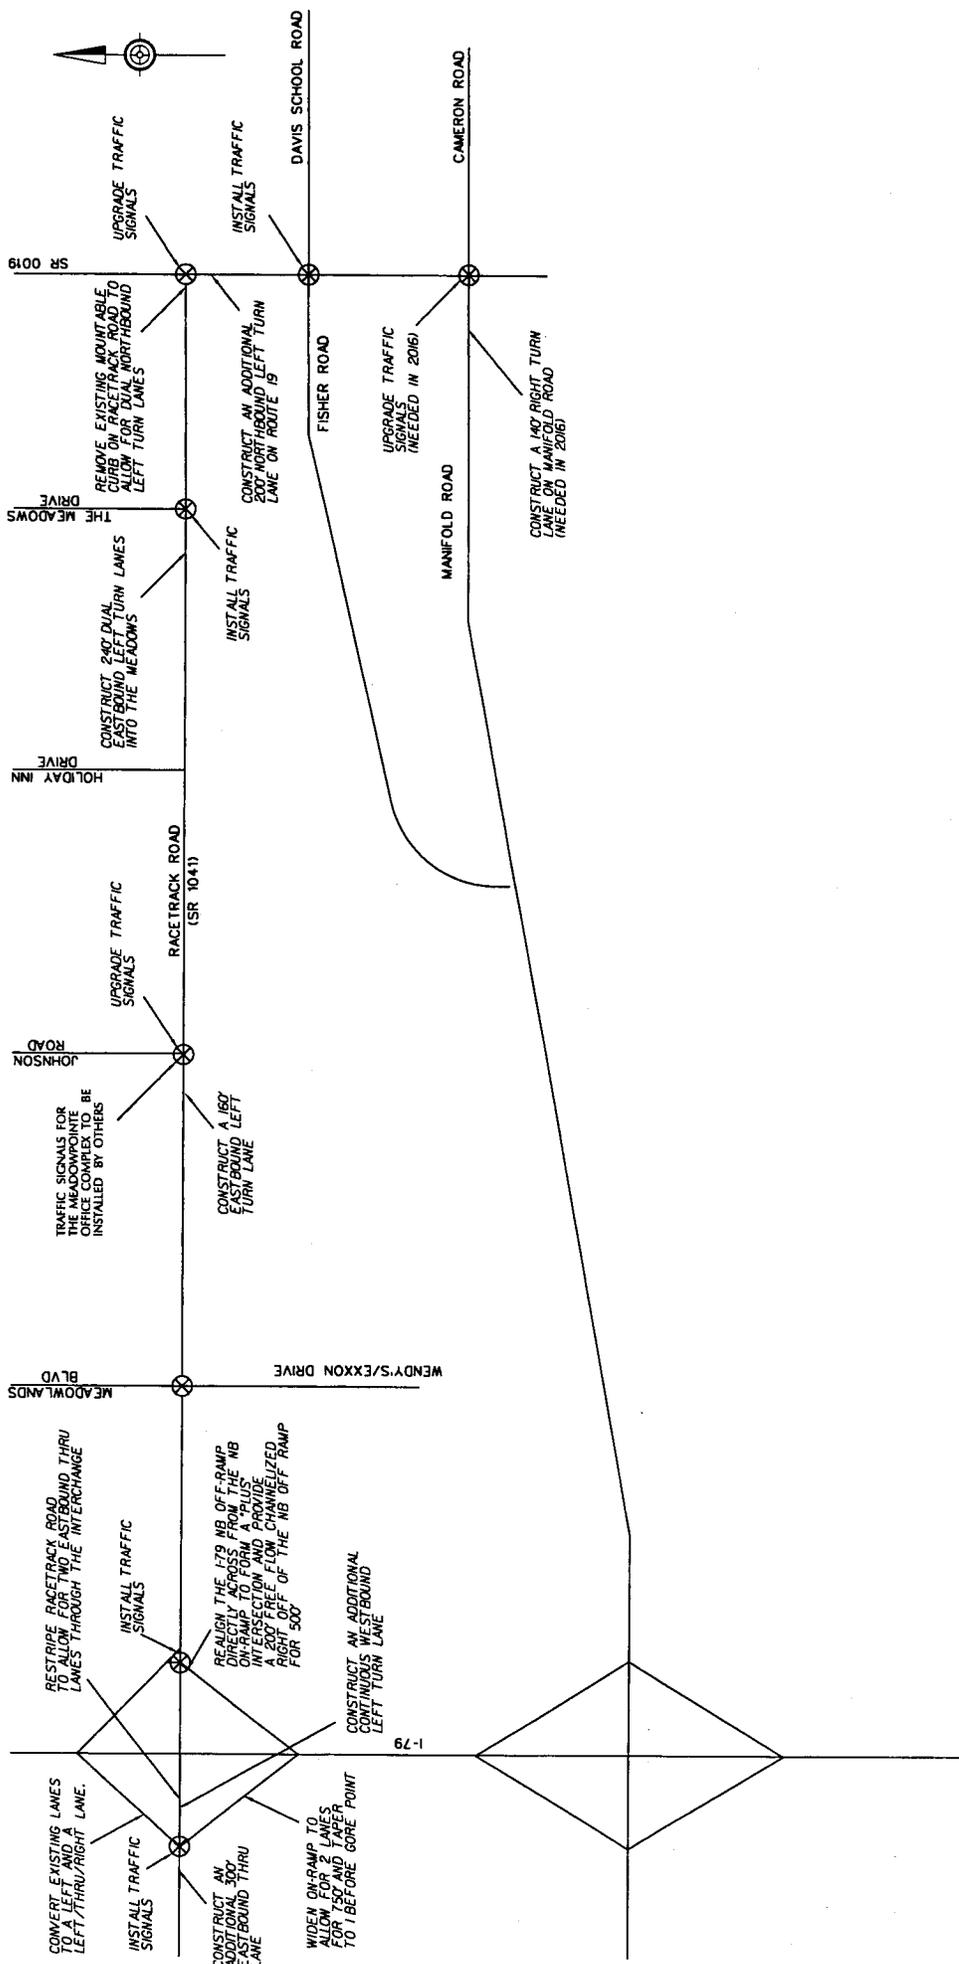
FIGURE: 4

400 TECHNOLOGY DRIVE, SUITE 100 CANONSBURG, PA 15317	THE MEADOWS	DATE: DECEMBER 2005 PROJECT NO: A0 4231
	REQUIRED MITIGATION-BUILD CONDITIONS WITH THE MEADOWS 3000 SLOT MACHINE EXPANSION ONLY	CHK: JPD SCALE: NONE
